This Service Information bulletin supersedes SI B41 04 08 **dated August 2009**.

Rear Axle Support Repair Procedure

E46 (3 Series)

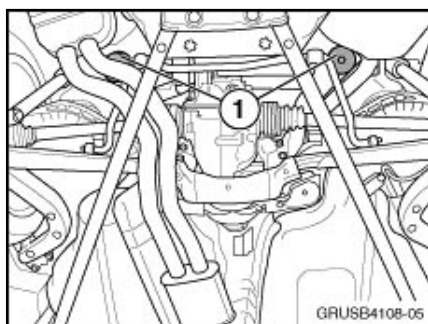
Under certain circumstances, a fracture in the steel body structure could form in the area around one of the rear axle carrier mounting points. As a result, a distinct clicking noise can be heard from the area of the rear axle carrier during certain driving conditions. Specifically, the noise may be heard during load reversals on the rear axle, such as when starting from a stop, engaging forward or reverse gears, or when rapidly changing gears.

Visually inspect the left rear mounting point for the rear axle carrier (left leader for #1 illustrated). If a fracture in the sheet metal is present, the length of the crack must be measured. If multiple cracks are present, measure the longest one.

- If the length is 20mm or **less** and the vehicle was produced **prior to** 10/2004, proceed to Procedure A.
- If the length is 20mm or **less** and the vehicle was produced **from** 10/2004, proceed to Procedure B.
- If the length is **greater** than 20mm, proceed to Procedure B.

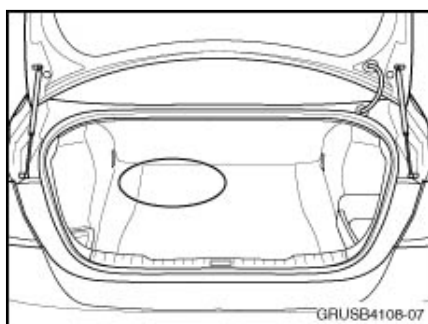
3. This illustration identifies the area inside the trunk where the following procedure will take place.

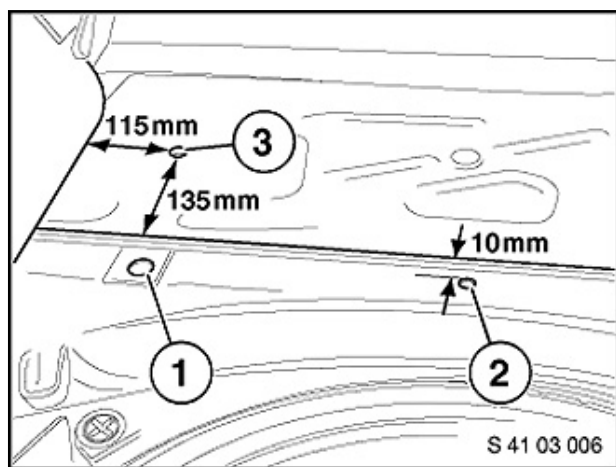
4. Identify the following 3 points which will be used in this repair. This area is located above the left rear mounting point for the rear axle carrier. Holes (2) and (3) will be filled with urethane seam sealer to create a barrier and thus a sealed cavity. Hole (1) will be filled with 2 complete cartridges of structural epoxy. These 3 holes will be referenced by number throughout this procedure.

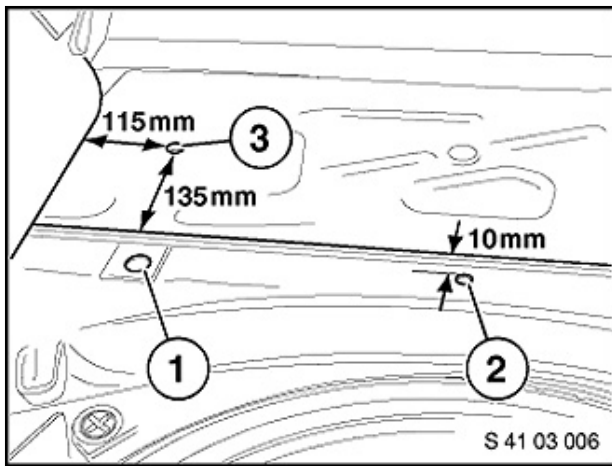
5. Hole (1) is present and is sealed with a body plug.
 Hole (2) is not present and must be drilled. It should be drilled halfway between Hole (1) and the similar hole on the right side of the luggage compartment. A 10mm stepped drill bit should be used.
 Hole (3) is present but is covered by

the anti-vibration liner. Locate the hole using the dimensions provided and expose the hole using suitable tools.

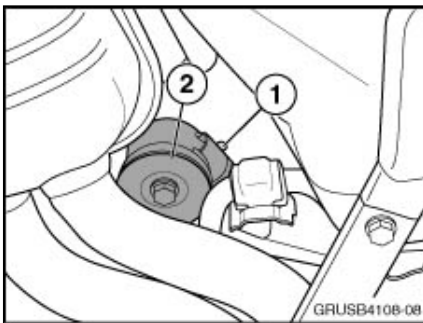
6. Use a length of tape or a body plug to seal the hole (1) from the underside of the vehicle if it is present on the vehicle.

This hole is located immediately to the right side of the left rear mount for the rear axle support (2).

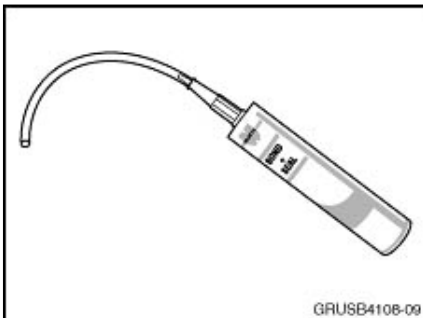
7. Prepare to install the seam sealer into Holes 2 and 3 from Step 4 by placing a 250mm (10") length of 3/8" clear flexible tubing (locally sourced) onto the nozzle of an open cartridge.

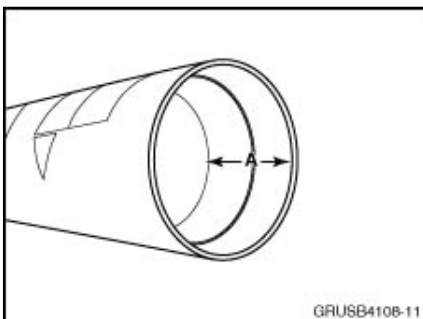
8. Looking at the bottom of the seam sealer cartridge, measure and record the distance to the plunger (A). This is necessary to ensure the correct amount of seam sealer has been injected since it's a blind operation.

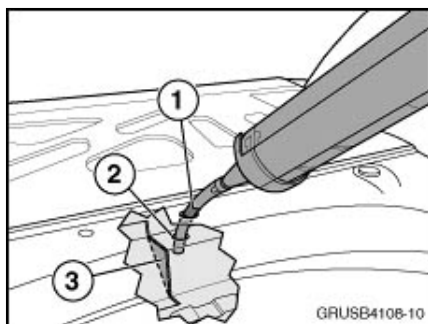
9. Place a tape line on the tube 120mm (4 3/4") from the open end. Insert the tube (1) into Hole 2 up to the tape line. Directly below Hole 2 is an existing

hole (2) of similar diameter. The plastic tube must go through this hole and reach the bottom of the cavity. This illustration shows a cutaway view to illustrate the triangular shape (3) of the cavity which is to be filled.

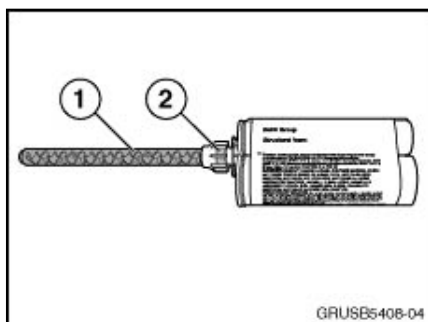
16. Remove the fastening nut and sealing plug from the structural epoxy cartridge. Next, install the mixing nozzle (1) onto the cartridge pack and secure it with the fastening nut (2), both of which are supplied with the cartridge pack.

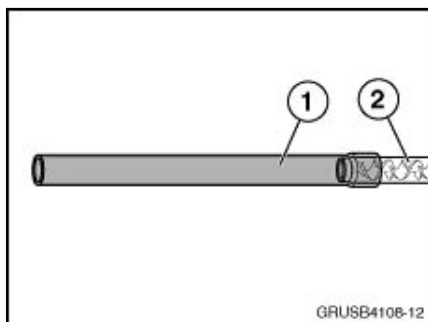
17. Install the included extension tube (1) over the end of the mixing tube (2).

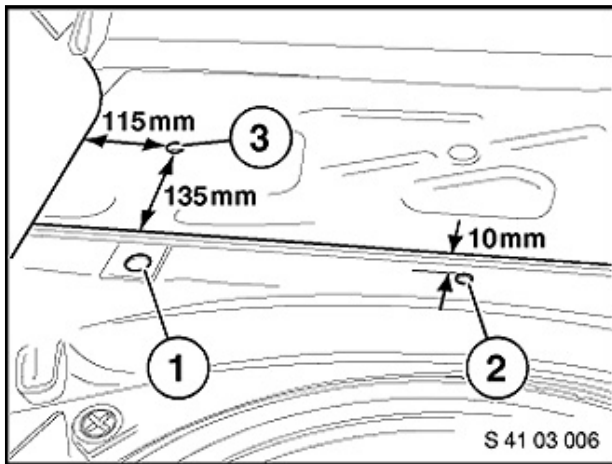
20. Feed the flexible extension tube into Hole (1). About 10mm below this hole is another hole which this tube must be fed through.

21. Inject the entire contents into the cavity. The red line on the side of the applicator will display how much has been injected. If the material begins to flow too slowly, warm the cartridge pack with an electric heat gun (set to low heat) to improve the flow.
