Parts and Performance for BMWs

Monoball FCAB Troubleshooting.

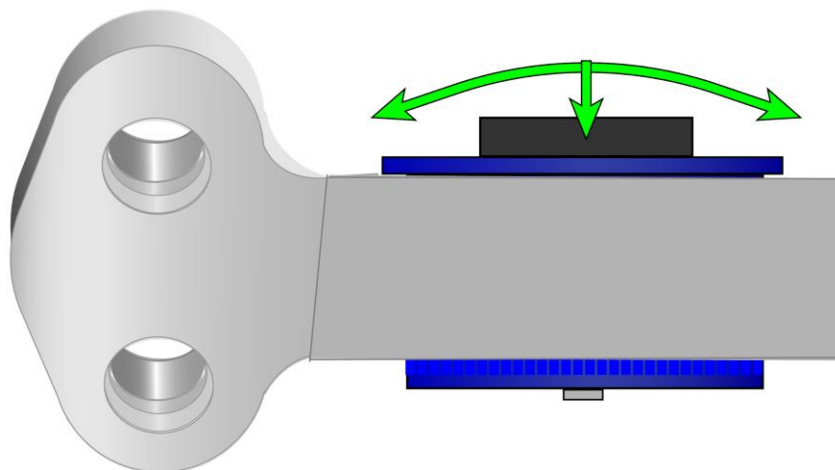
- When the bearing is pressed into the housing, but not yet installed on a control arm it must rotate freely in all directions.

- If the spherical bearing is binding after installation, press it back out, thoroughly clean all burrs from the OD of the bushing and bushing bore in the lollipop housing, then press the bushing back into place. In some cases, you may have to do this more than once, depending on variations in the tolerance of the bracket bore.

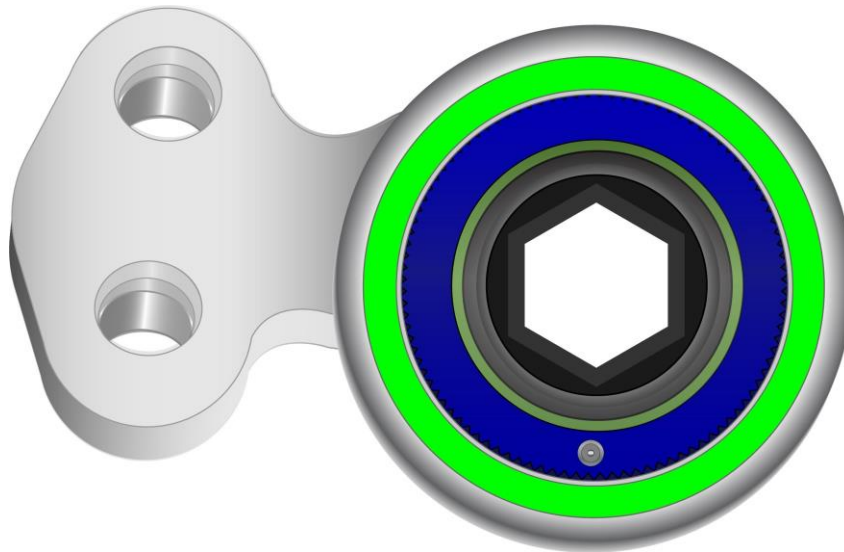
The bearing should require medium to light tapping with a hammer to be installed on the control arm. We do not recommend tapping on the bearing insert for install as that can push the insert out of the bearing as it goes on the arm. Instead, we prefer that the bearing assembly is tapped on from the lollipop housing as this assures that the complete assembly is fully seated. (Area shown in green)

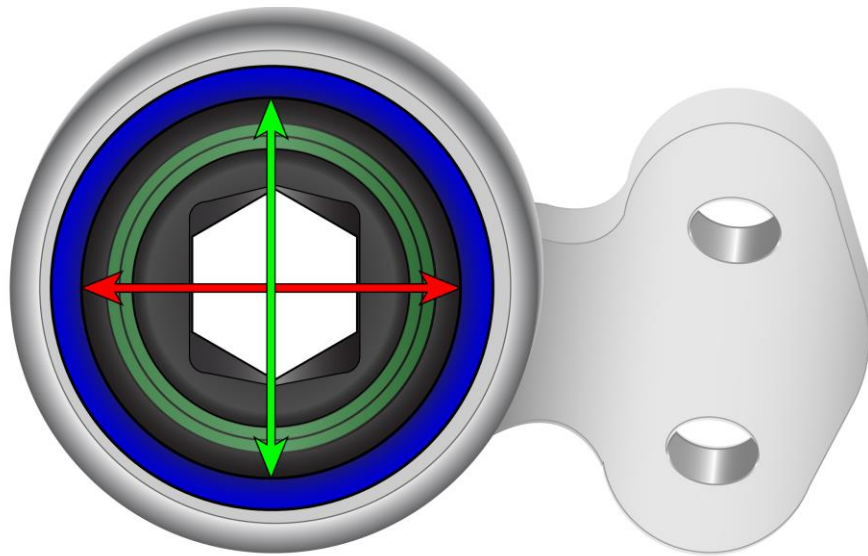
- When the bearing and housing are installed on the control arm the bearing's entire range of motion must remain. While uncommon, some control arms have been found to distort the insert and ID of the bearing, causing the bearing to lose complete spherical rotation.
 - If the bearing does not move freely by hand once installed on the control arm, the hex portion of the control arm will need to be altered. The areas that need to be modified can be located by finding the areas of the bearing that do not/ are difficult to move, these areas are causing the bearing ID to deform and will filed/ground down.

For example: If the bearing moves freely in the direction of the green arrow, but not in the direction of the red arrow, the hex portion of the control arm will need to be ground/filed in the flats/corners nearest to location of the red line.

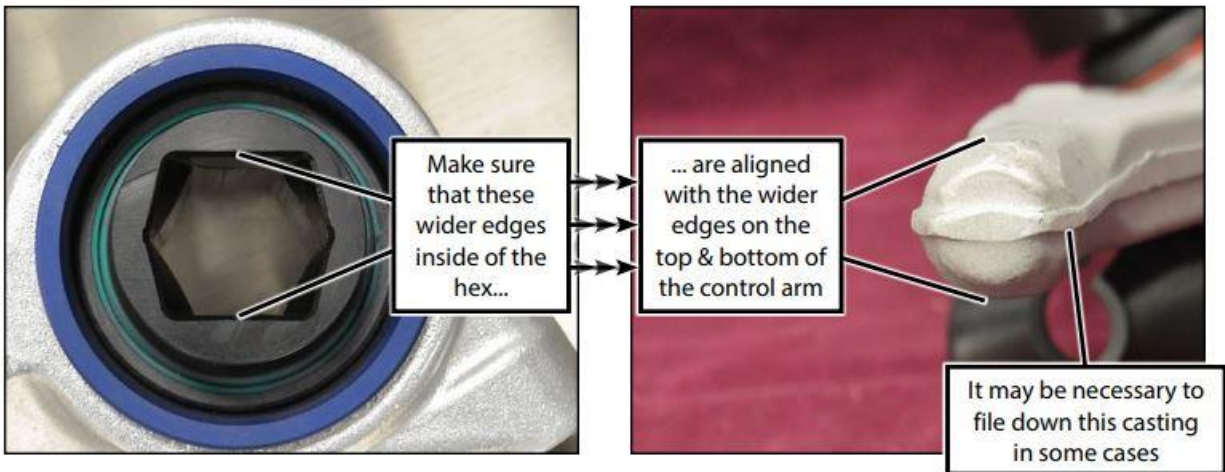
- If the lollipop housing is very difficult/cannot be installed on the dowel pins of the body do not force it. Forcing the lollipop housing onto the dowel pins will thrust load the bearing and cause a creaking/popping noise. The most likely cause of dowel pin misalignment is a bearing that is not fully seated on the control arm. Instead, the bearing insert must be fully seated on the control arm to ensure easy alignment with the dowels on the body.
- On hex shaft applications such as the E46 M3, proper bearing insert orientation is critical to achieve full insert. Make sure that the hex insert is properly oriented with the hex of the control arm. The wider flats of the hex insert need to be aligned with the top and bottom of the control arm to fully seat.

- If the hex is correctly oriented and the issue still persists, the hex transition of the control arm may need to be filed/ground to allow the insert to be installed further.
