E46 M3 Structural Foam Installation

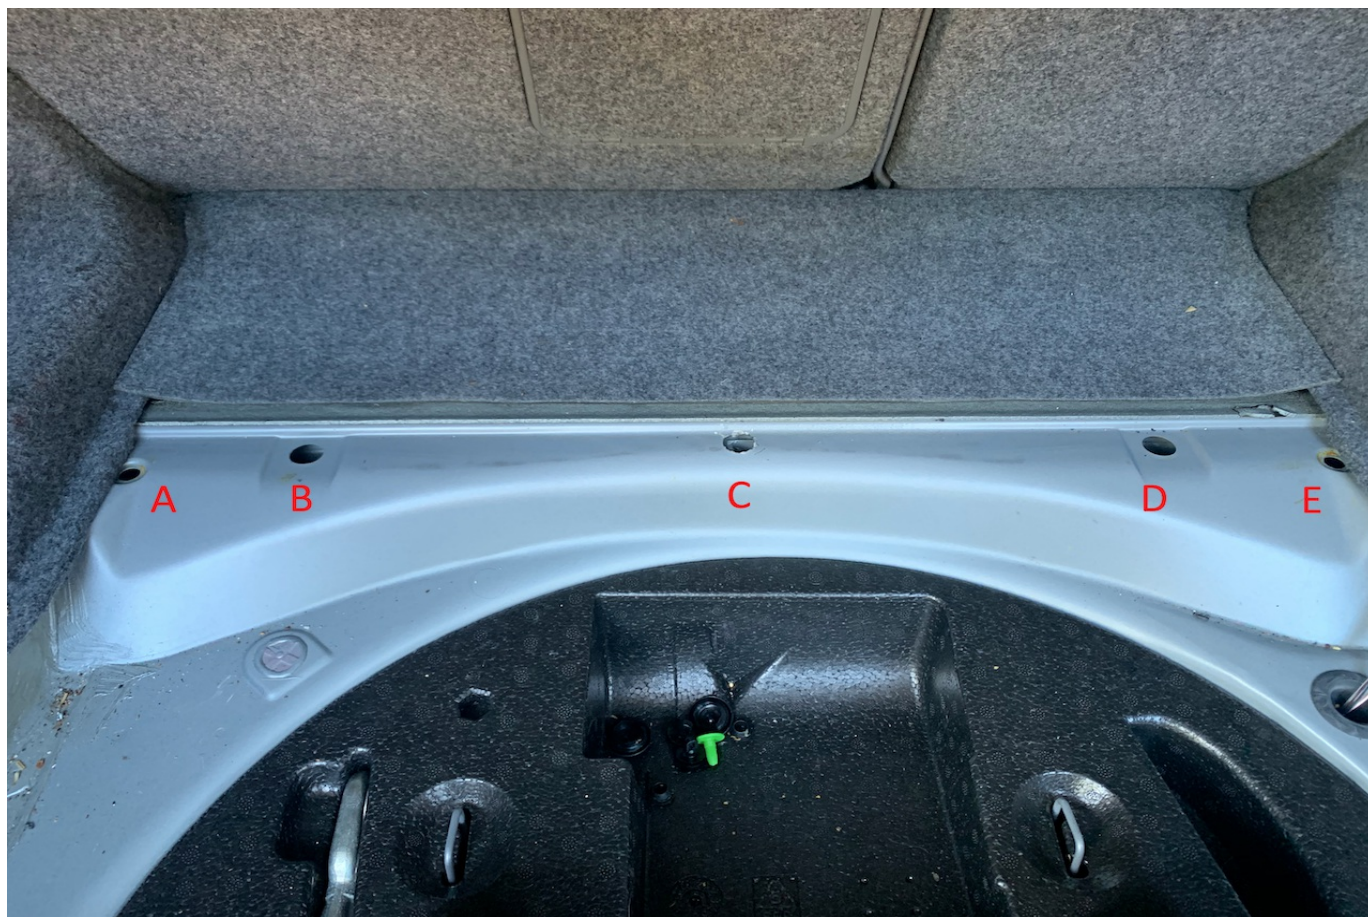
For reference, here is a top view of the area above the rear mounts (facing towards the front of the car).

A total of five holes can be seen. Four are existing factory holes (A, B, D, E) and are plugged from the factory. Hole C is user-drilled. A 1cm tall cavity extends the width of the trunk under the area from A to E. A taller cavity containing the mounts sits directly under this. The left rear mount sits in this lower cavity between holes A and B and the right rear mount sits between holes D and E. The five holes have matching holes in the roof of the lower cavity so there is direct access to it.

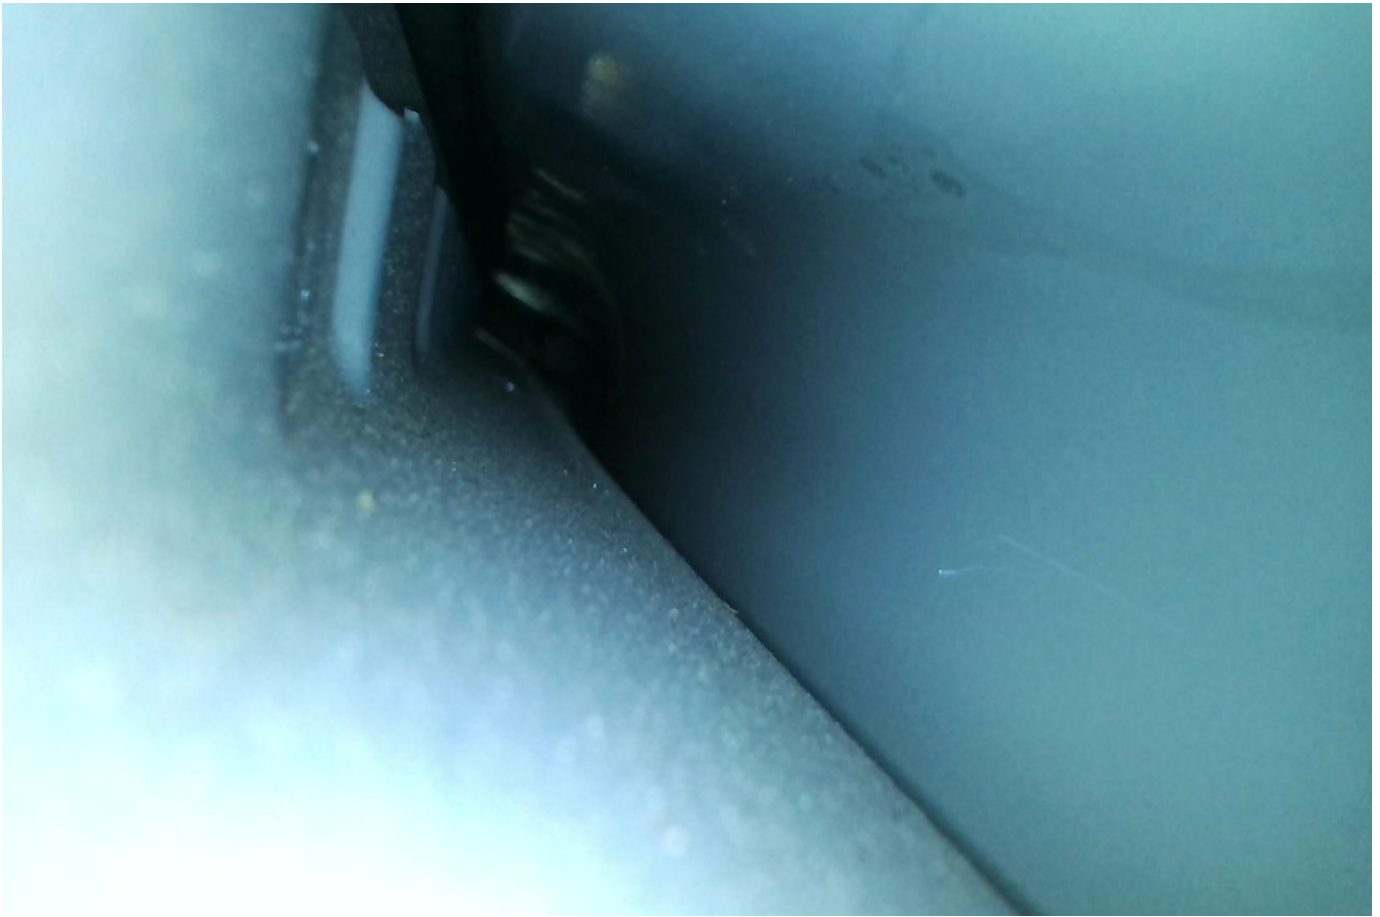
Here is a view of the upper cavity with the boroscope inserted into hole B. Here the boroscope is facing towards the right of the car, with hole C dimly visible in the distance.

This upper cavity does not have to be filled with foam according to the BMW procedure, though some have reported filling it in any case.

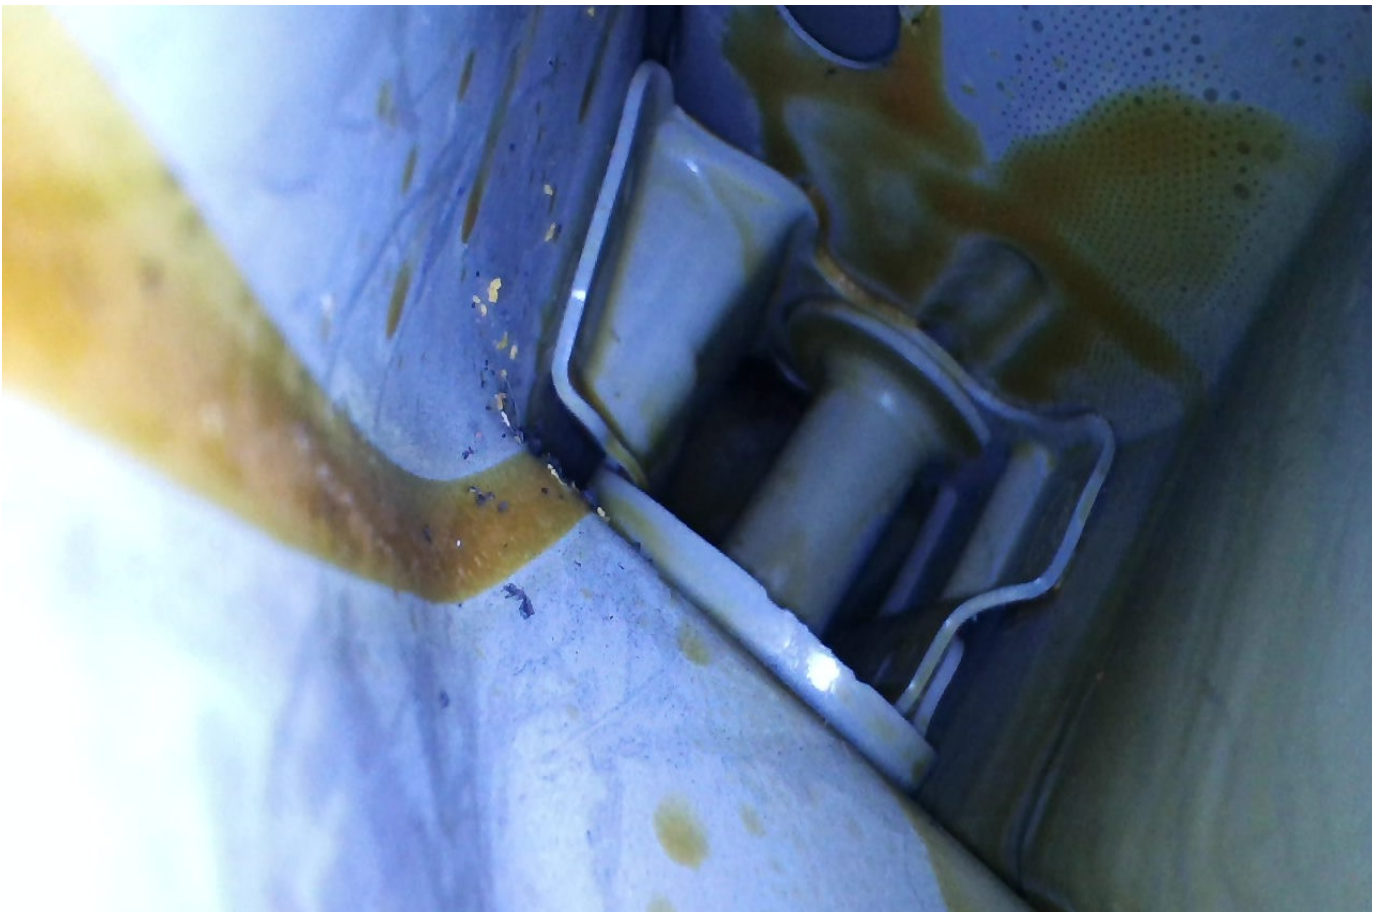
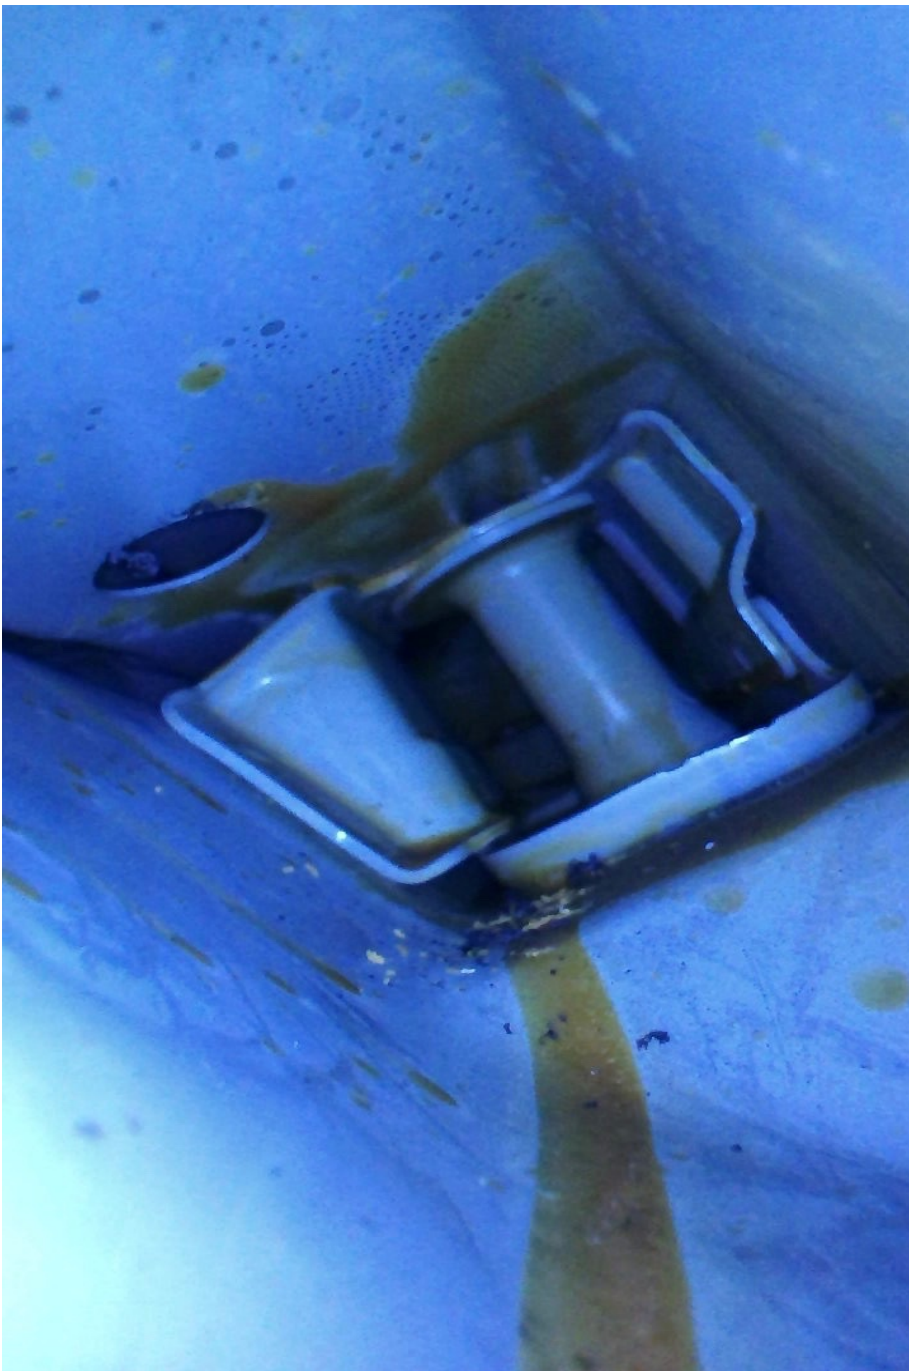
Here are some views of the left rear mount in the lower cavity with the boroscope inserted into hole C.

Hole B is clearly visible. Hole A is on the other side of the mount.

As can be seen, the mount is spot welded to the top and bottom and the front and rear sides of the lower cavity.

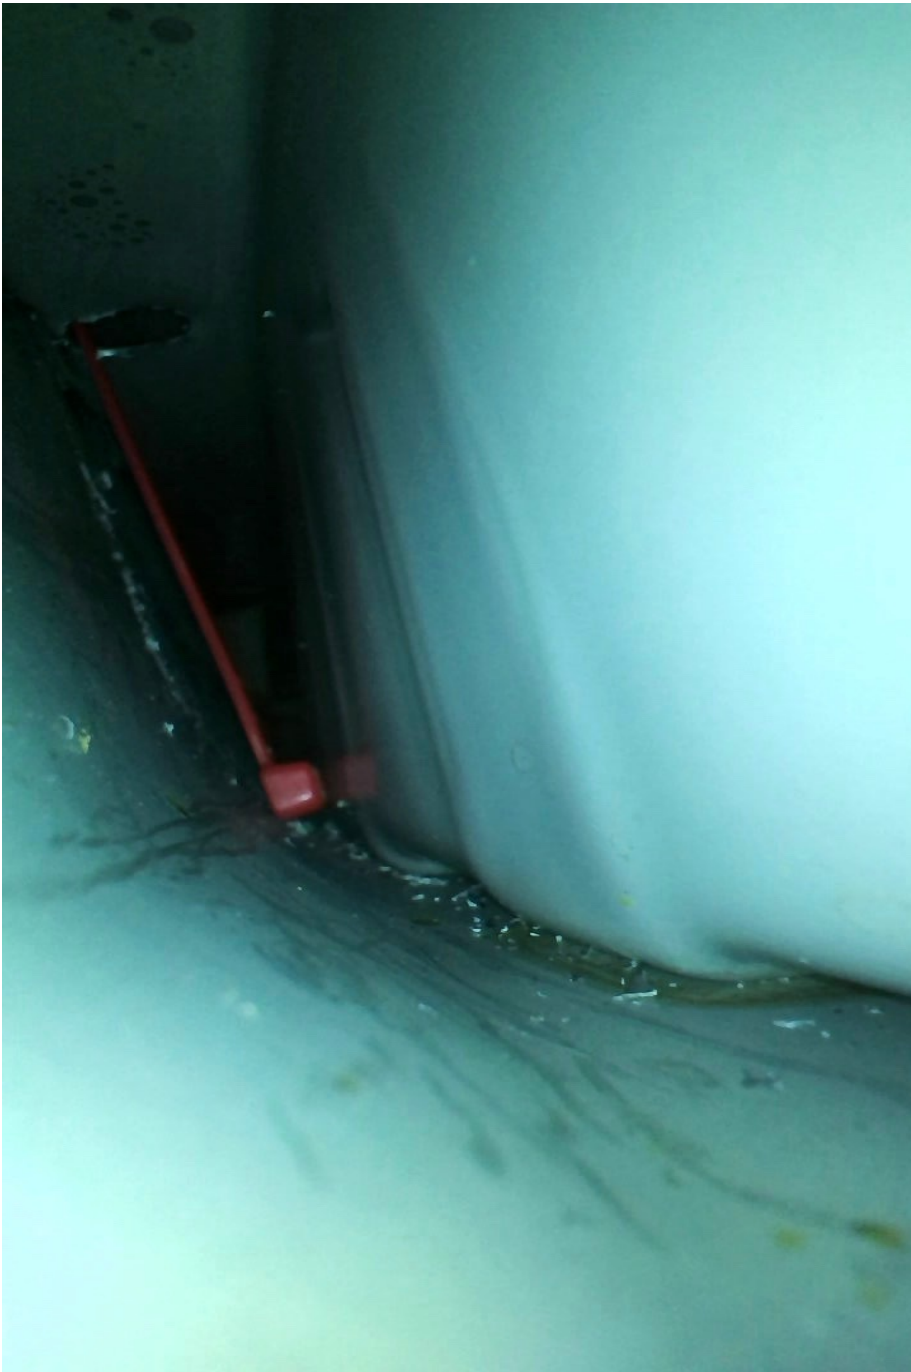
Here is a view from hole B towards the center of the lower cavity. A red Zip Tie I inserted into hole C is visible.

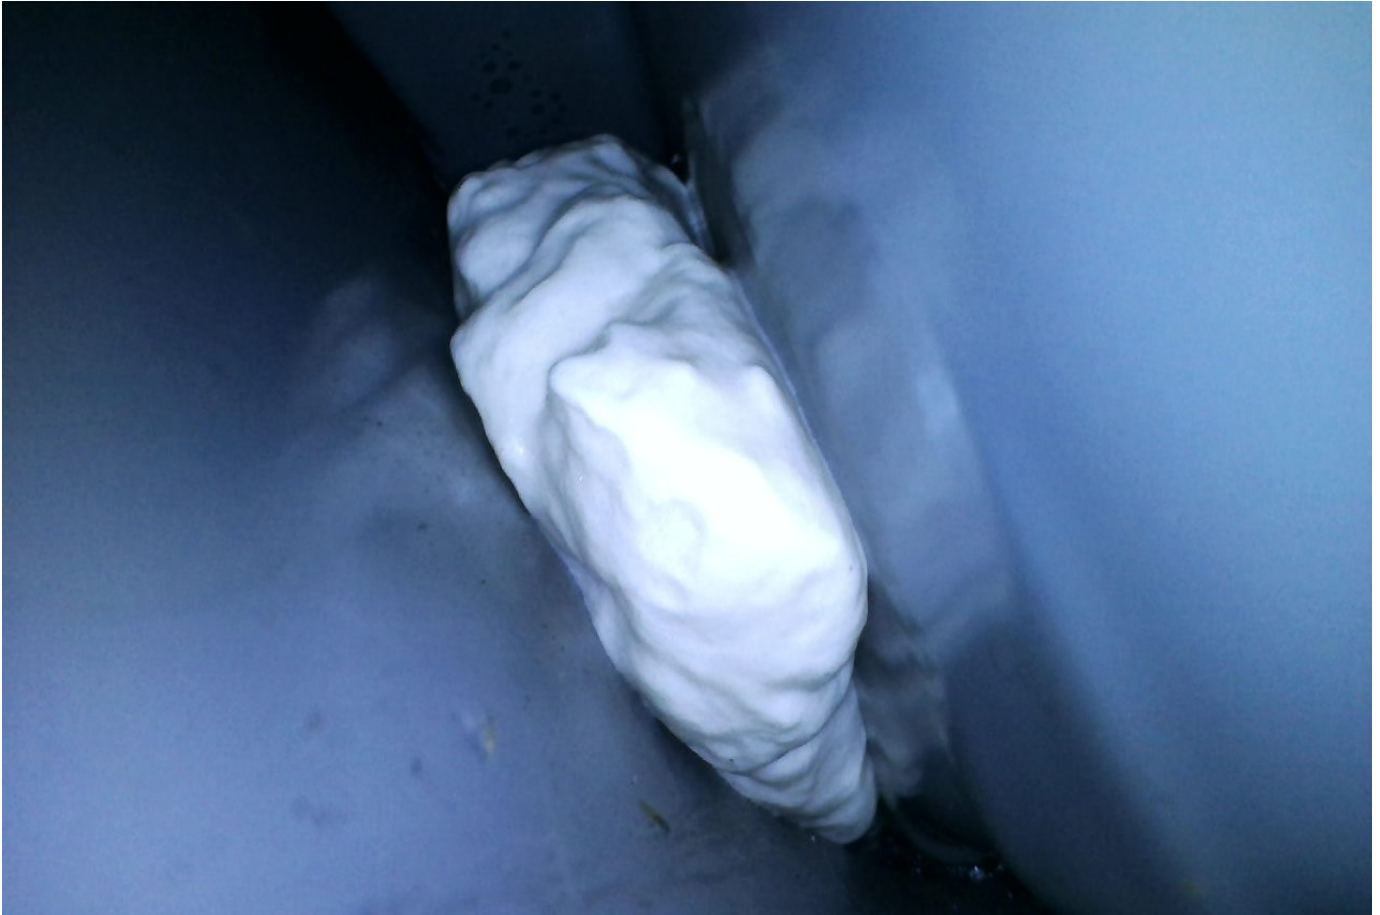
The BMW procedure involves sealing off the left side of the lower cavity from the right by injecting the gap filler into hole C. Here is a view of the area under hole C with the gap filler shown immediately after injection.

The filler effectively isolates both sides of the lower cavity.

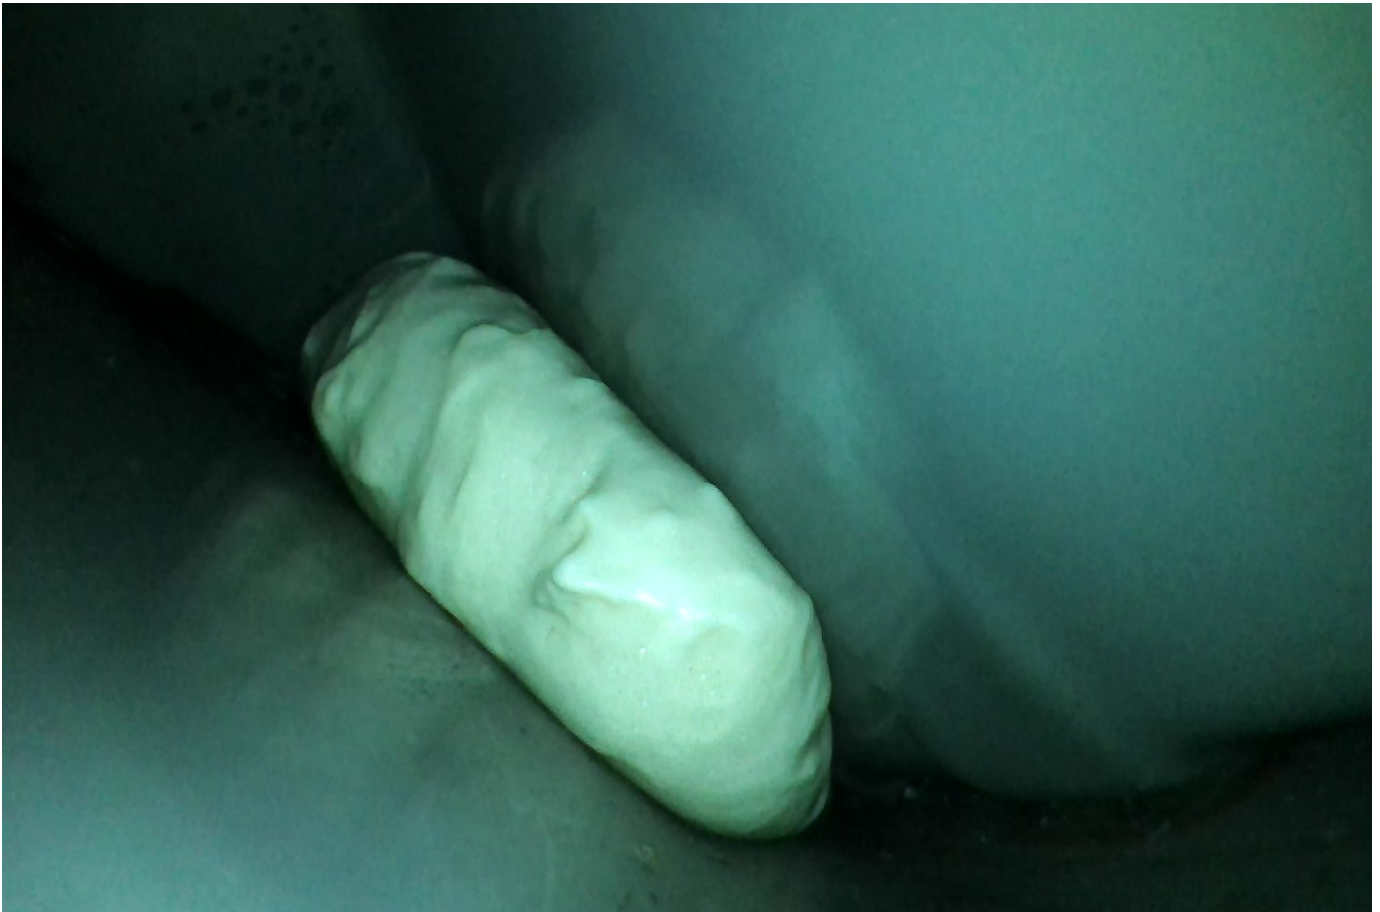
Here is the final cured gap filler.

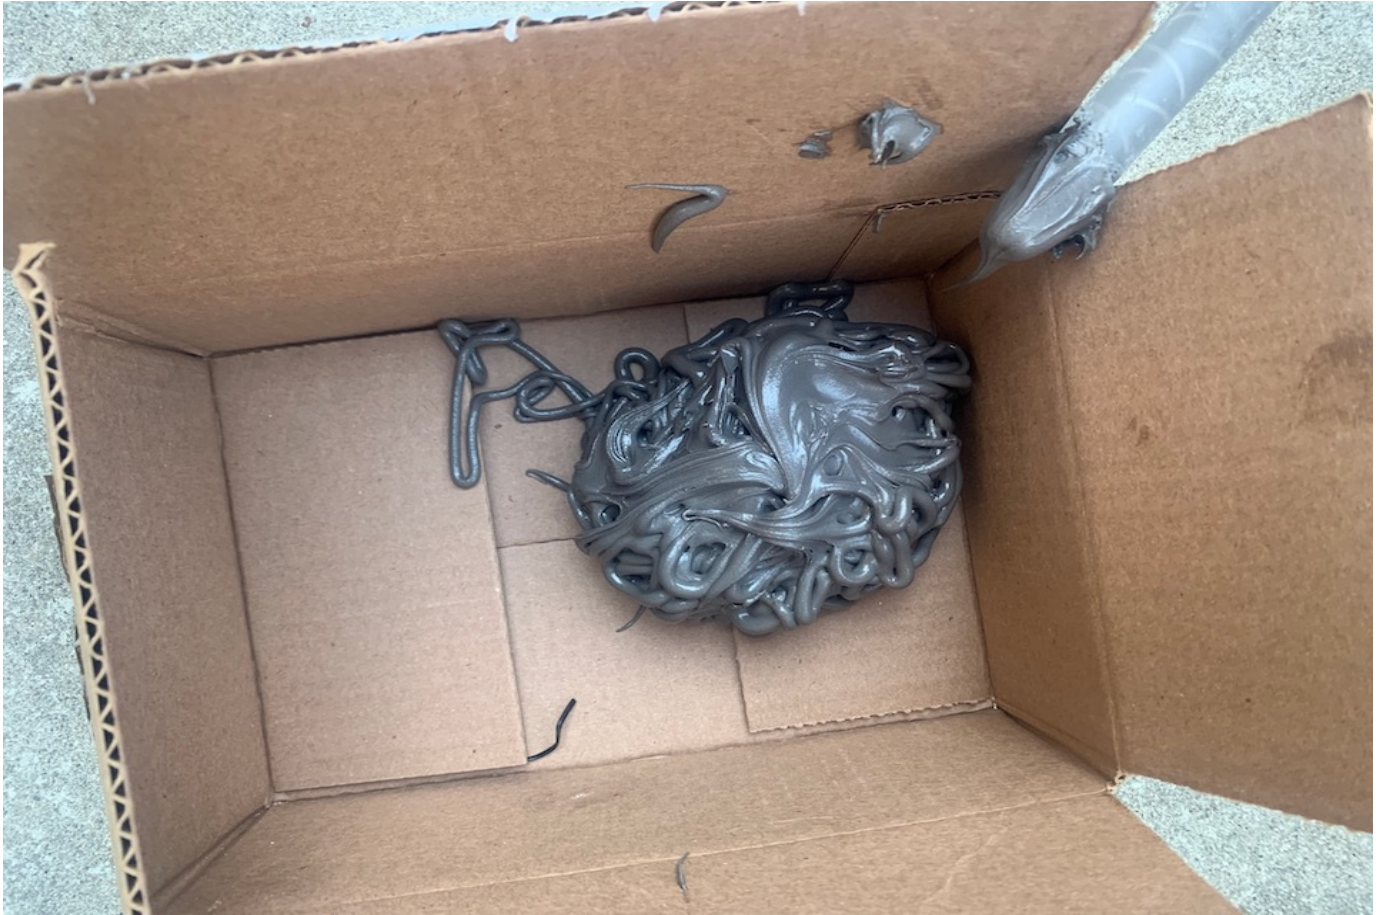
Here is a picture of the foam injected into a box (I effed up my first injection attempt, which is why I ended up with \$80 of goo in a box).

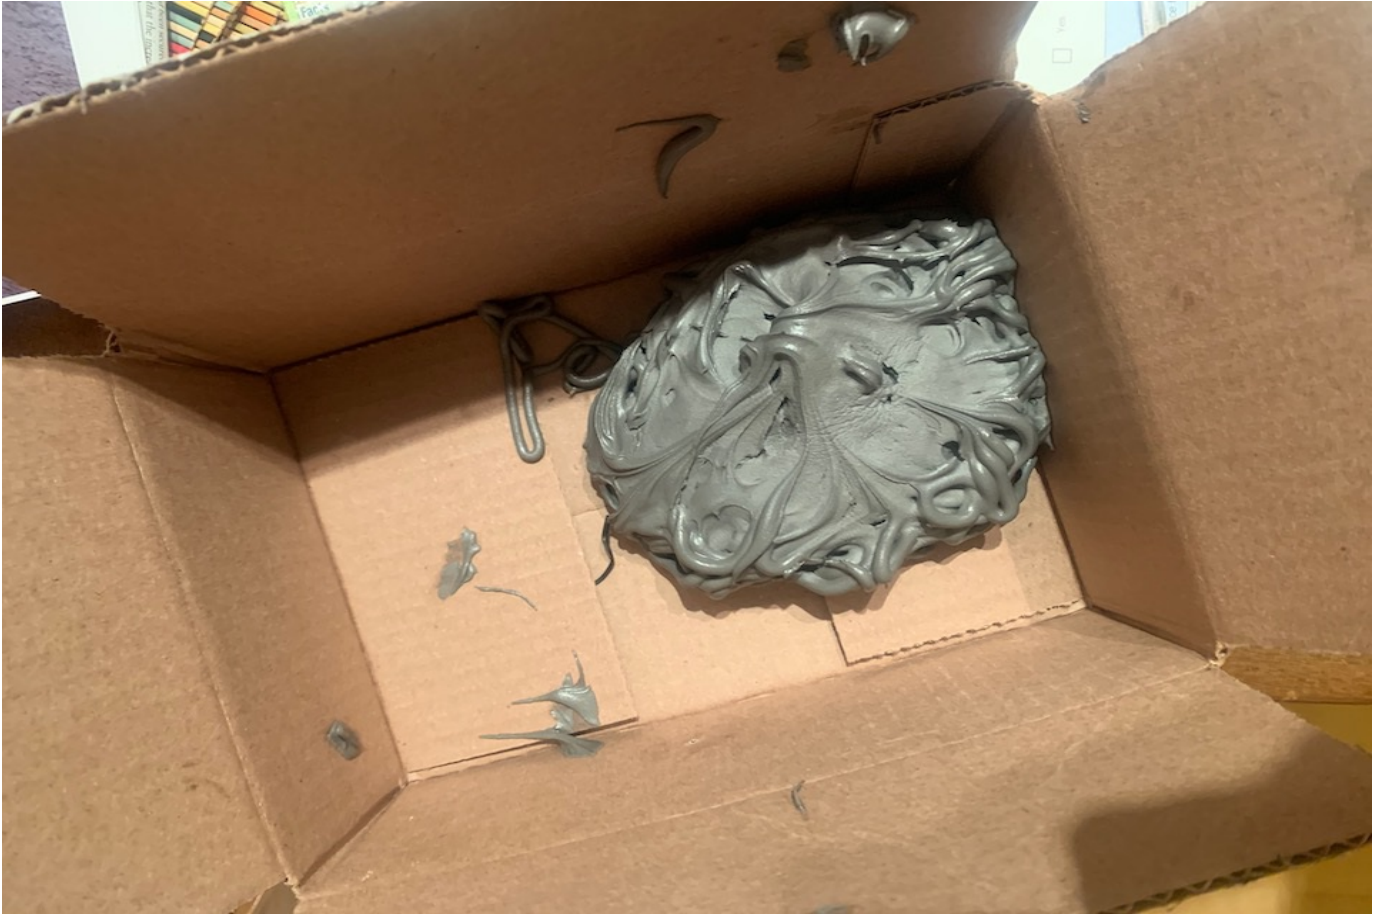
Here is a picture of the cured foam 24 hours later.

As can be seen, the foam does expand slightly when cured but is not self-leveling. Given this, I think it is pretty important to inject the foam on both sides of each mount since I don't think gravity will evenly distribute the foam. I suspect a lot of it could end up towards the center of the lower cavity if injected only in holes B and D.

So, when injecting I used both holes. Unfortunately, it is not possible to directly see where the foam actually goes after installation but it is possible to indirectly infer based on the (surprisingly brisk) heat from the injected foam.

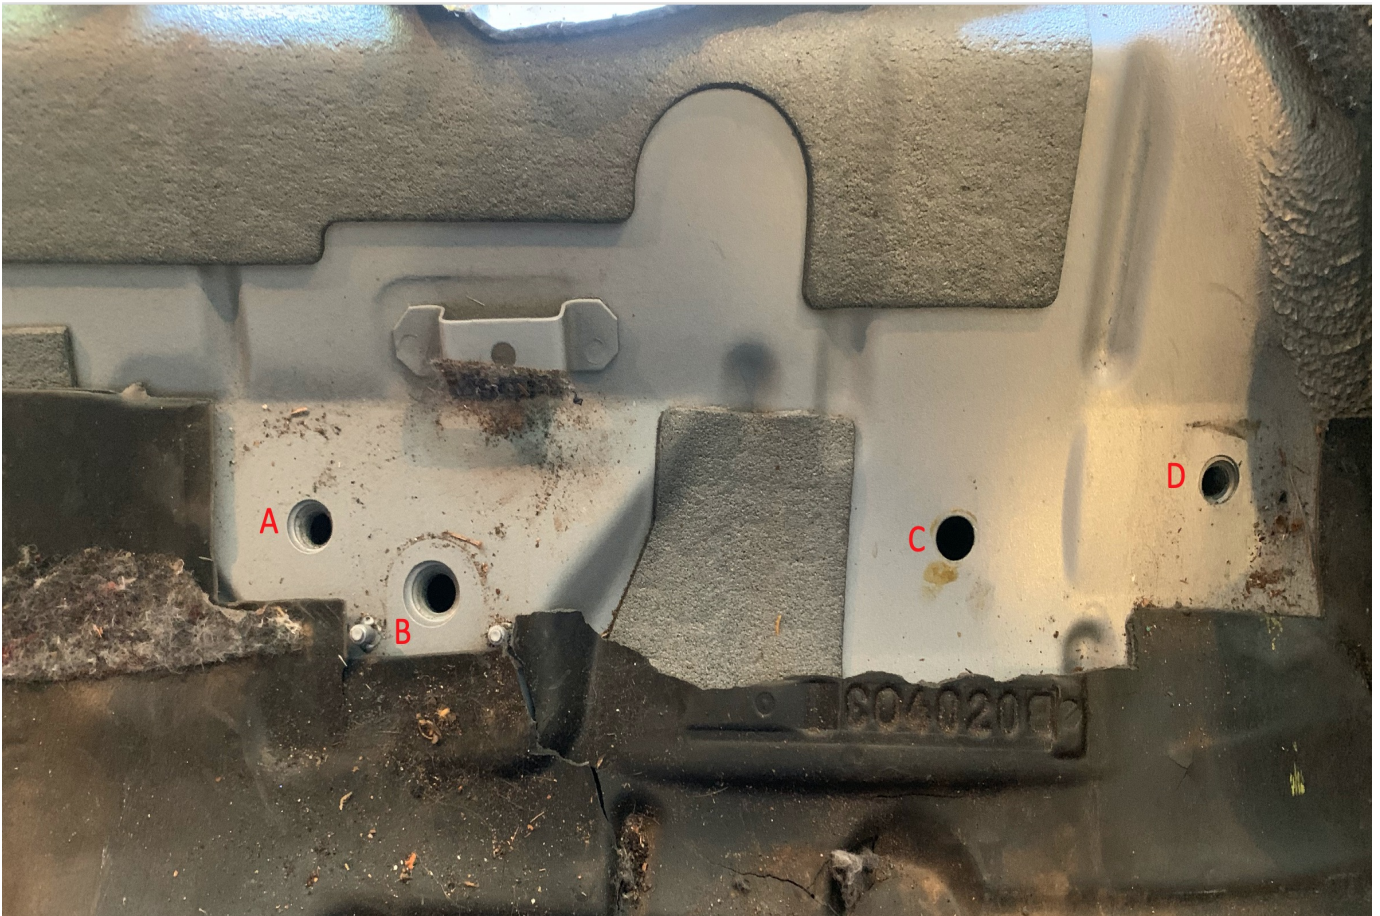
Here is a picture of the left top side of the RACP (facing towards the rear of the car).

All four holes are factory drilled. Holes A and D are tapped for the rear left seat hinge brackets, B is tapped to hold the rear left seatbelt, and C is unused and has a factory plug.

The left front subframe mount sits between holes B and C, though is slightly closer to hole B

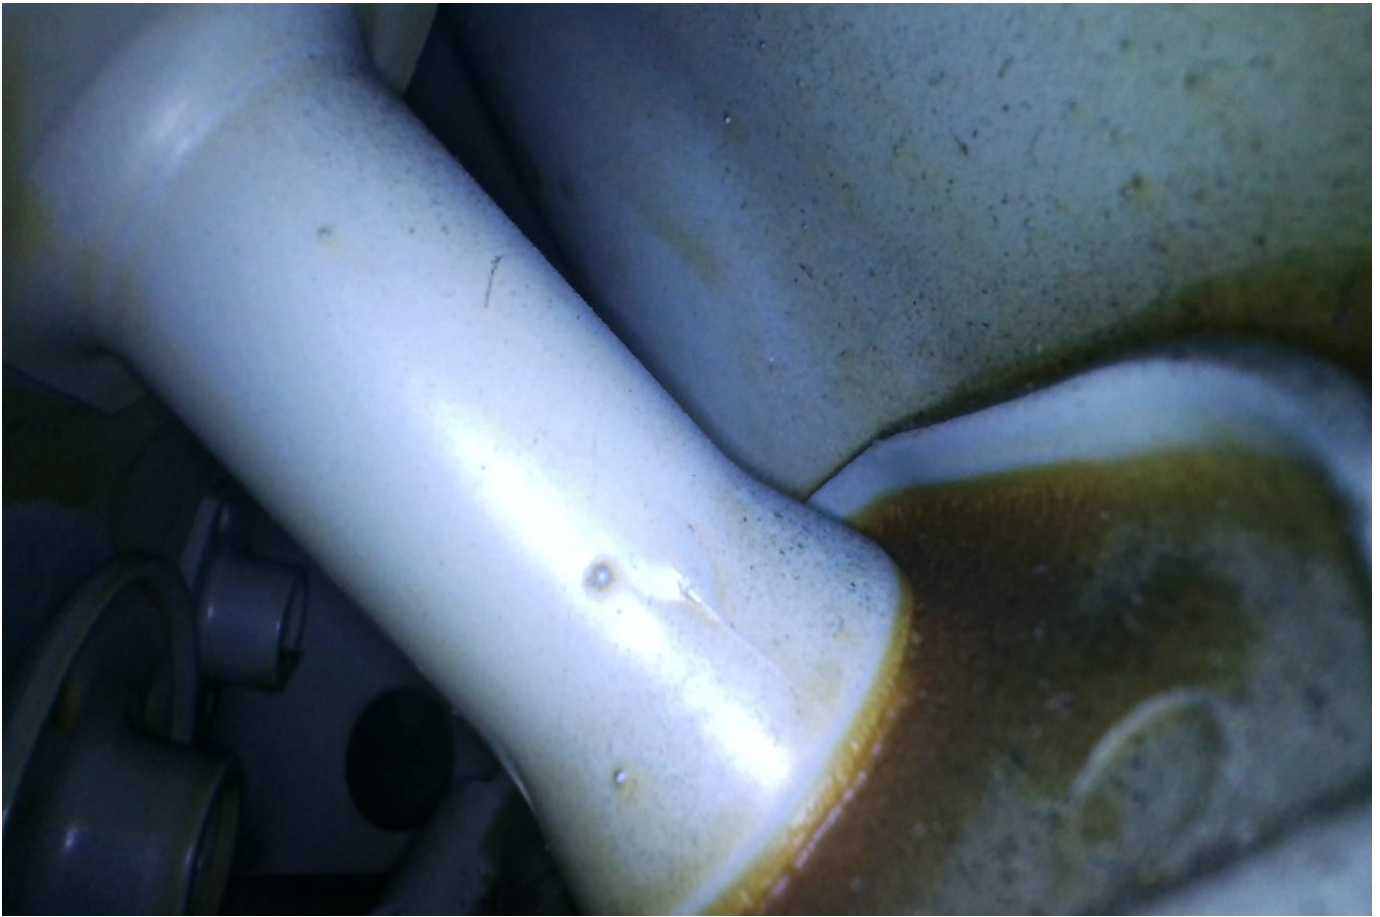
Here is a view of the left front subframe mount inside the cavity. The top and bottom of this mount are welded to the ceiling and floor of the cavity.

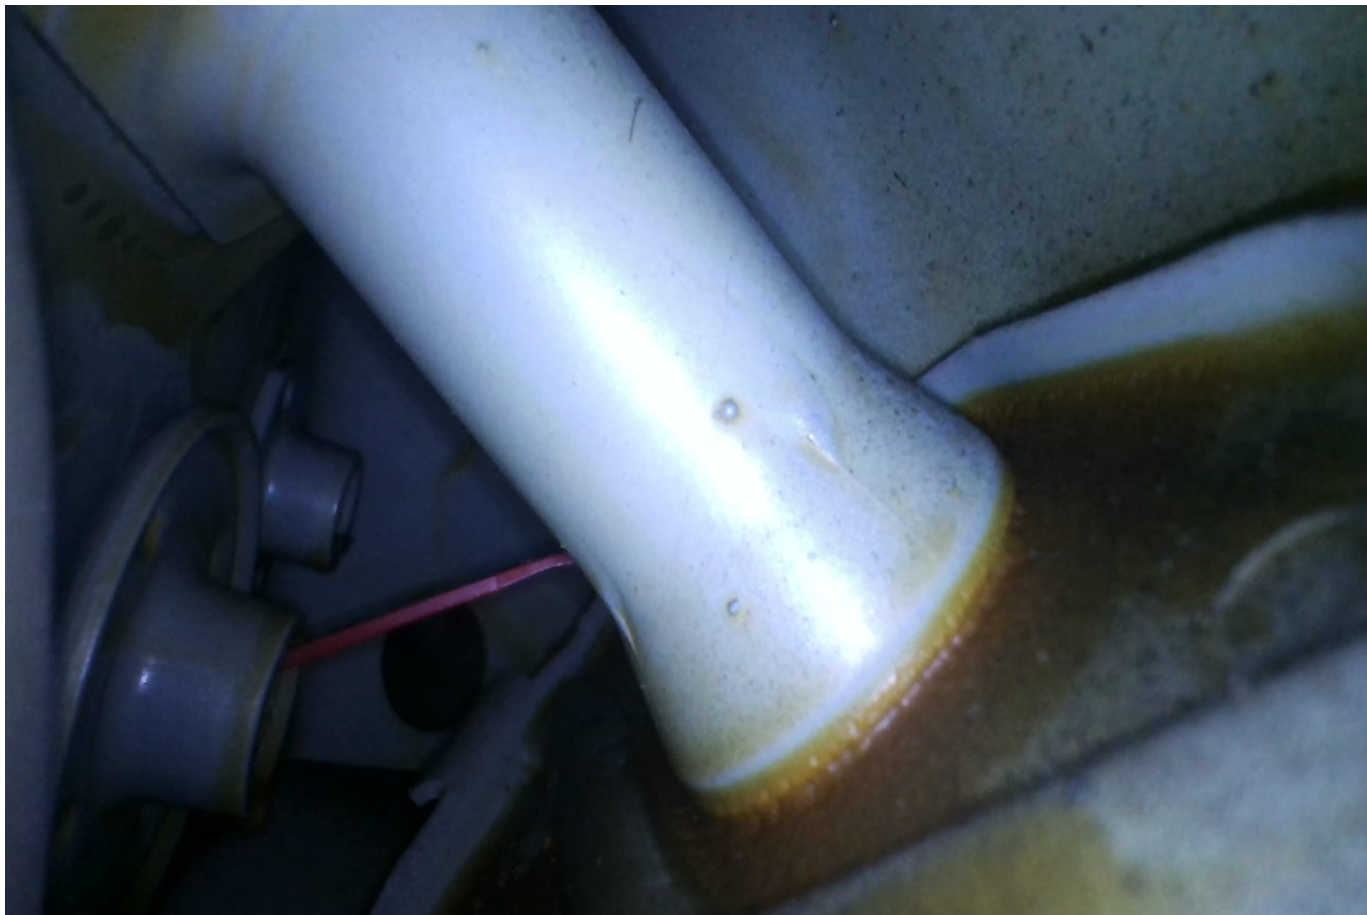
Here is a view that also shows the underside of holes of A and B. A red ZipTie is inserted into hole B.

Unlike the rear cavity, which extends uninterrupted for the width of the car, the front cavity appears to have a panel in the middle, though it has a circular hole in it.

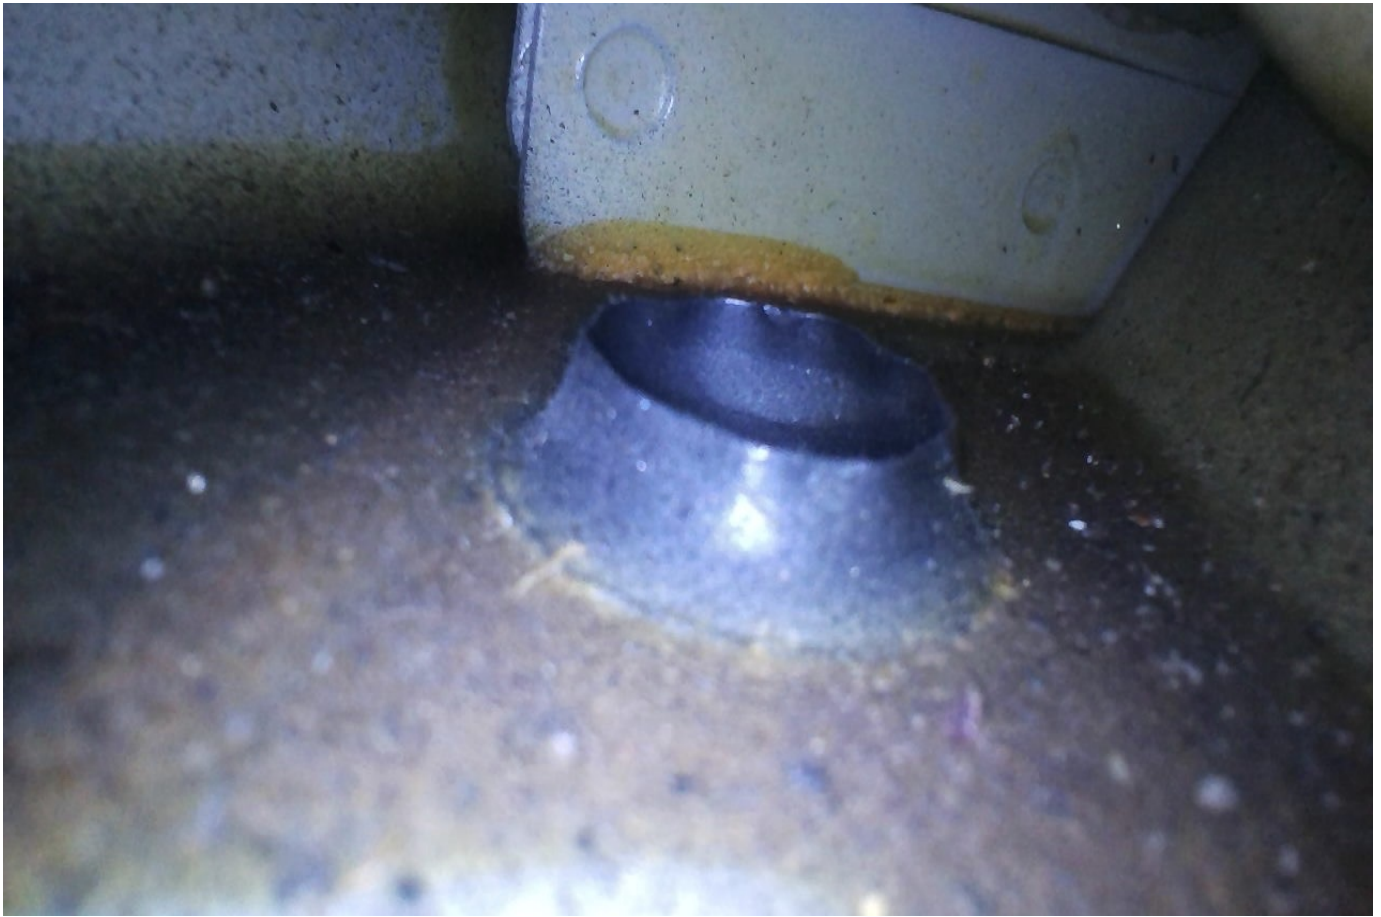
Here is a view from hole C towards the left-hand side of the car.

As can be seen, the cavity terminates immediately after hole D.

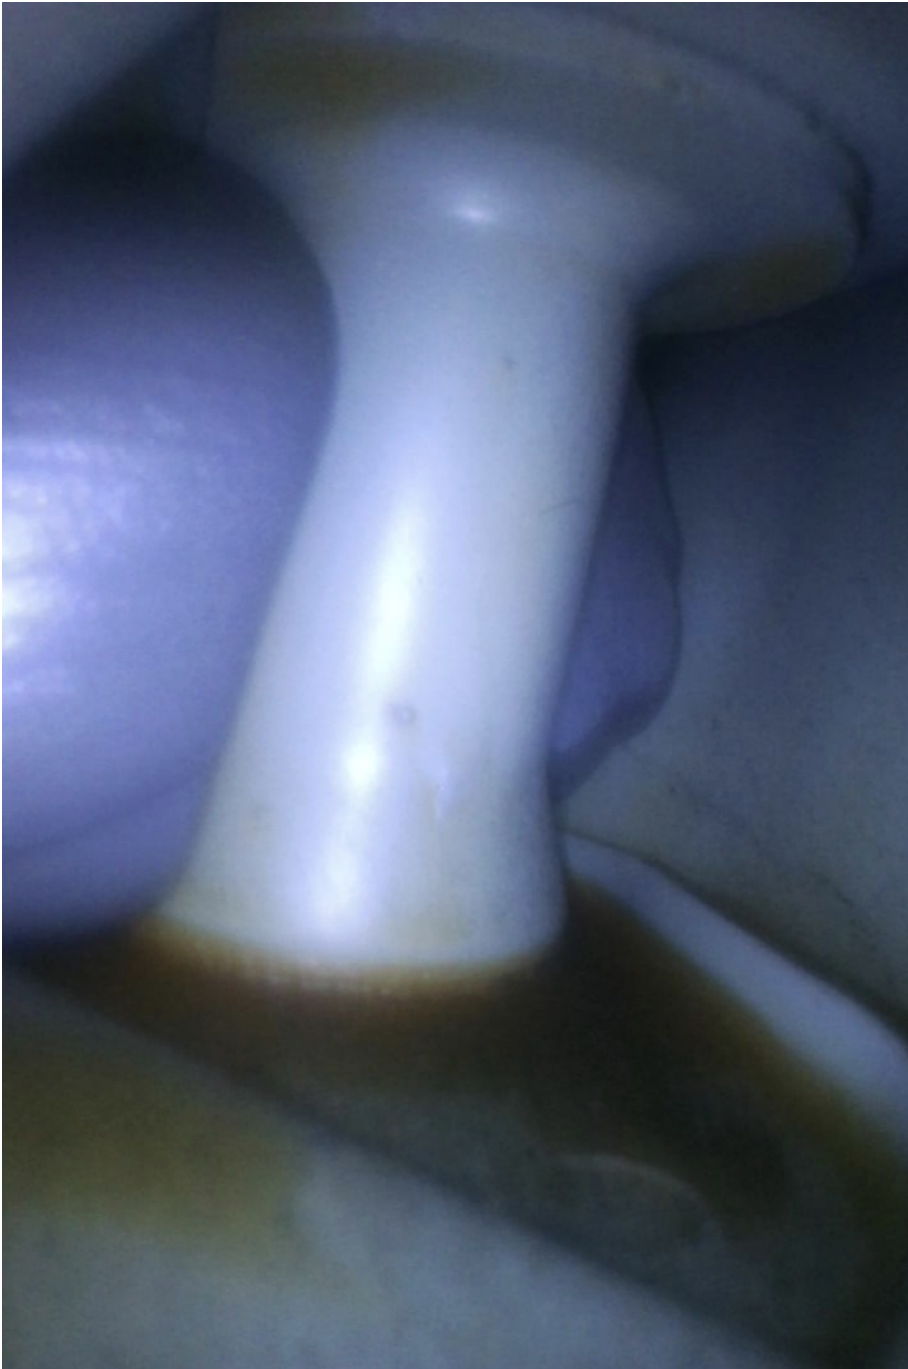
Here is a picture of the left front mount immediately after the injection of structural foam into hole B.

As can be seen, the foam is beginning to surround the mount even before the curing expansion process - which is exactly what you want to see.

After foam is injected on the other side of the mount it will be completely enclosed - and bonded to the RACP permanently.

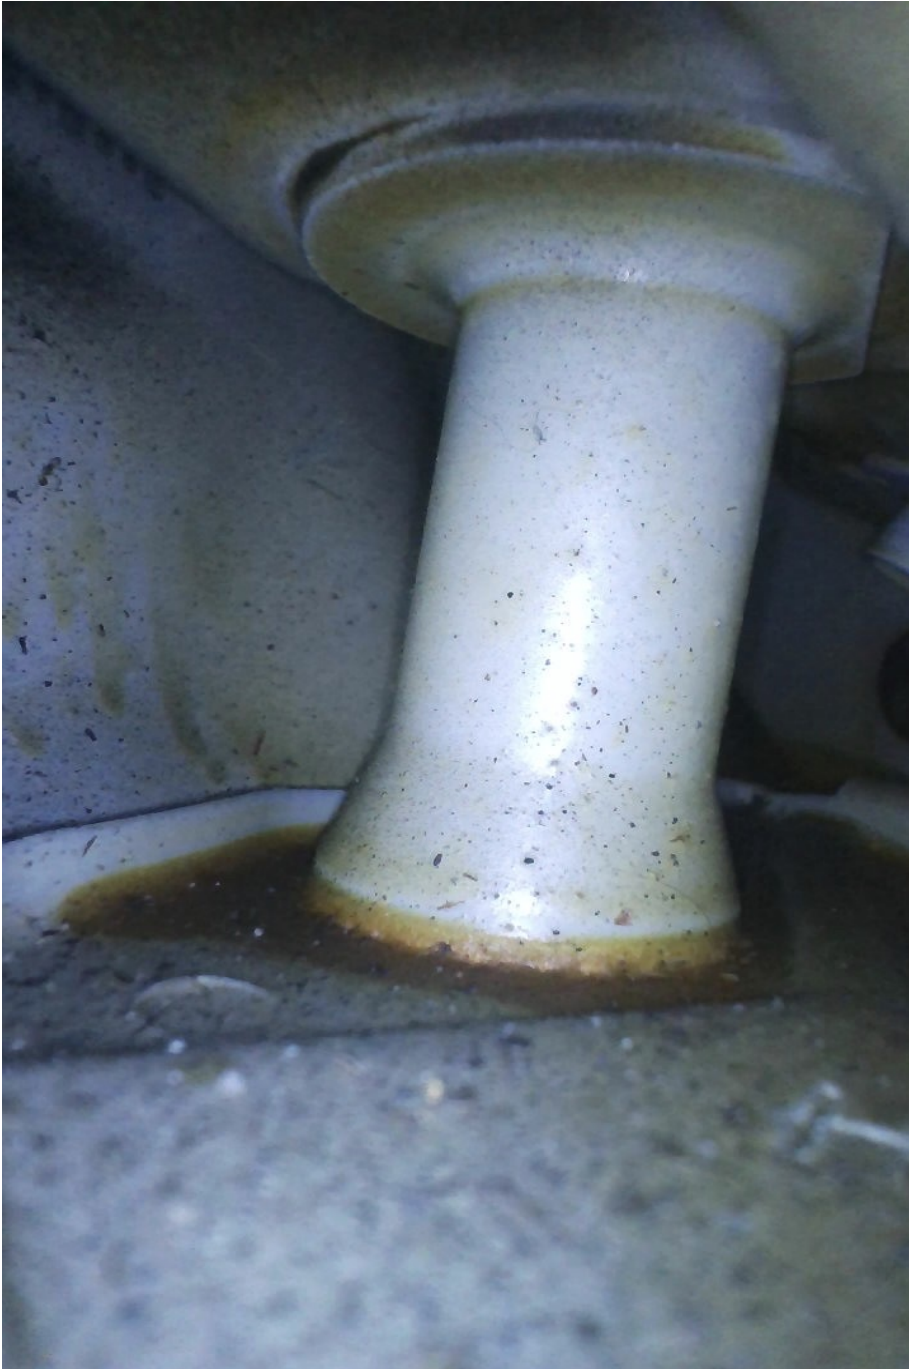
For completeness (and to verify that the cavity is symmetrical side-to-side) I also inserted the boroscope into the right side of the cavity. Here is a view of the right front subframe mount inside the right side of the cavity.

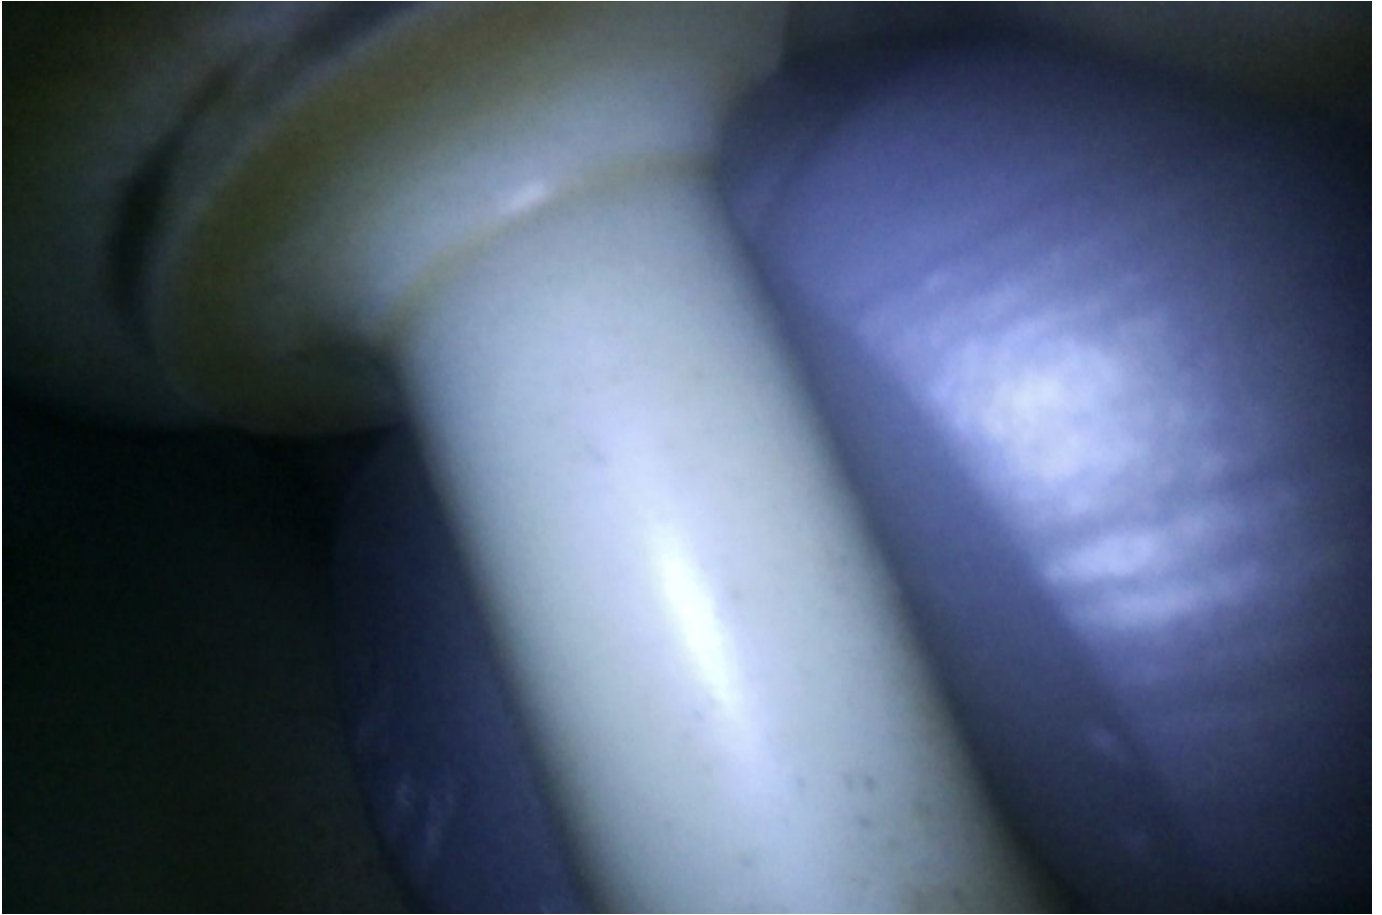
And, finally, here is the right front mount after foam is injected on the opposite side of it.
