**DIY: Alternate Rear Subframe Repair Method (Check the top of fwd mounts AND Spot Welds)**

**E46 M3 (2001-2006)** Engine: S54 - Max Hp: 333 hp at 7,900 rpm / 262 lb/ft at 4,900 rpm  
Total Produced: 45,000+ - Years Produced: 2001 to 2006.

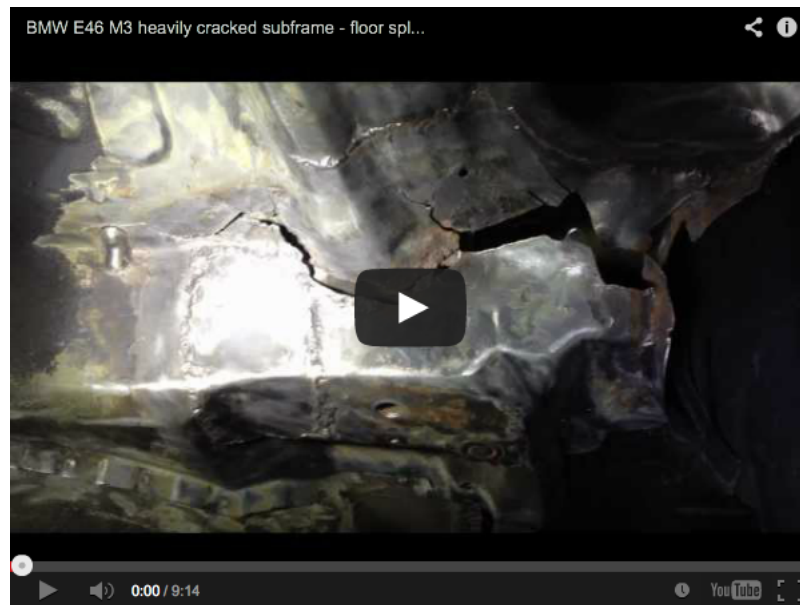
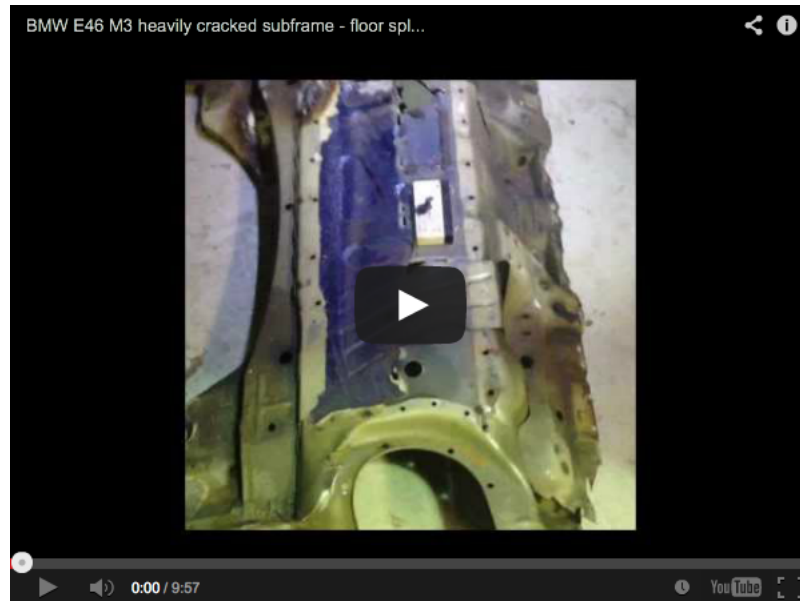
**Credit of this repair method:** many of the DIY'ers and contributors in m3forum and e46fanatics forum, European Car Company of Wichita KS that gave me countless hours of advice, some of my colleagues, some friends who helped me on final installation and most importantly: Redish Motorsport from LA. Redish posted and shared some of the greatest information about the **subframe** floor structure and failure cause about the E46 M3. It was their YouTube video that helped me find the (typical E46M3) cracks on the sheet metal panels and spot weld cracks. I highly recommend every E3 owner to watch all of their **subframe** YouTube videos. These are my favorite ones and explained why the convertible is better (not because of stronger floor but with the bulkhead aft of the rear seat to provide out-of-plane stiffness to the floor/subframe chassis):

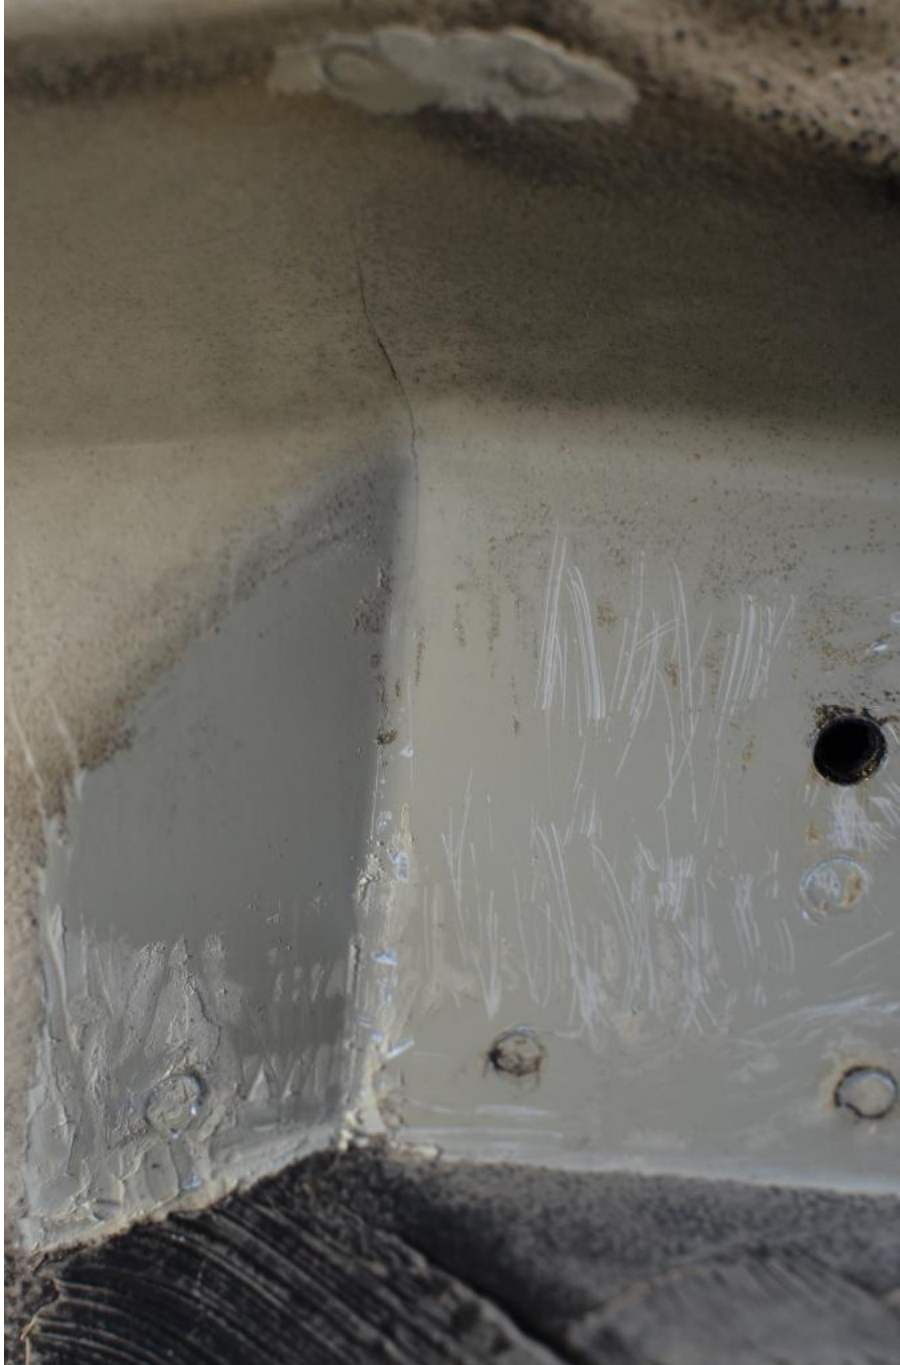
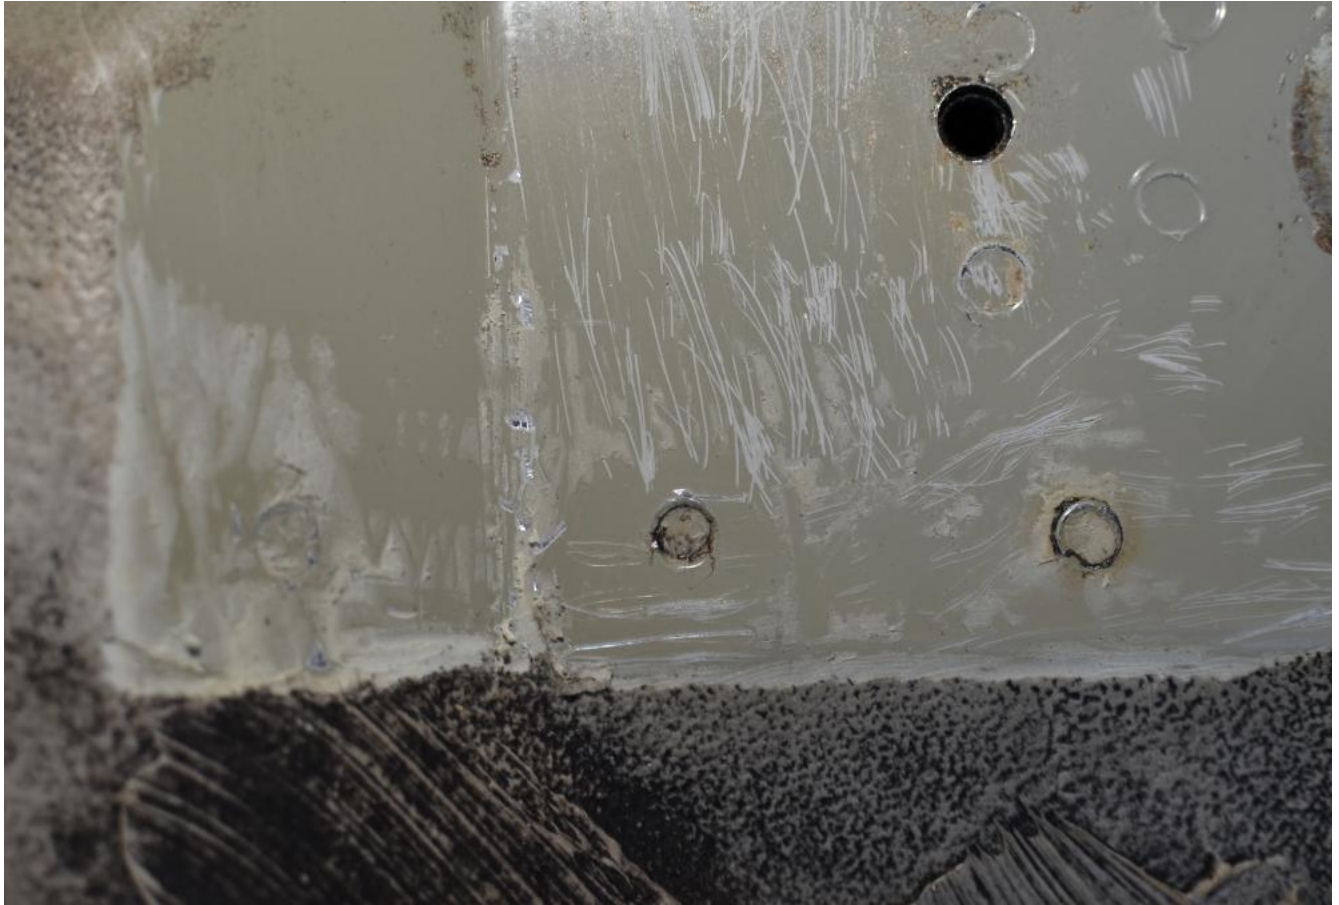
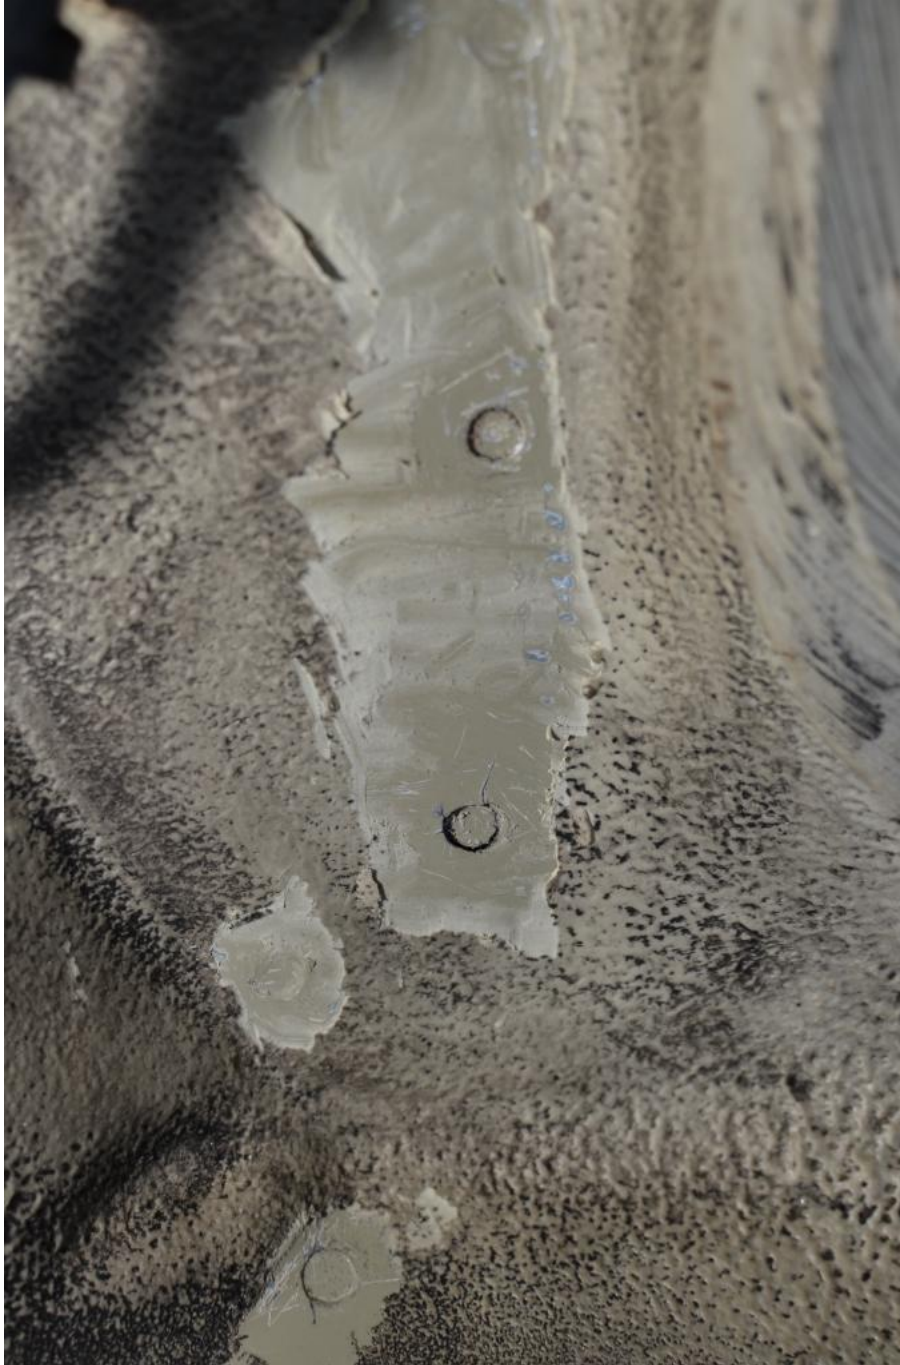
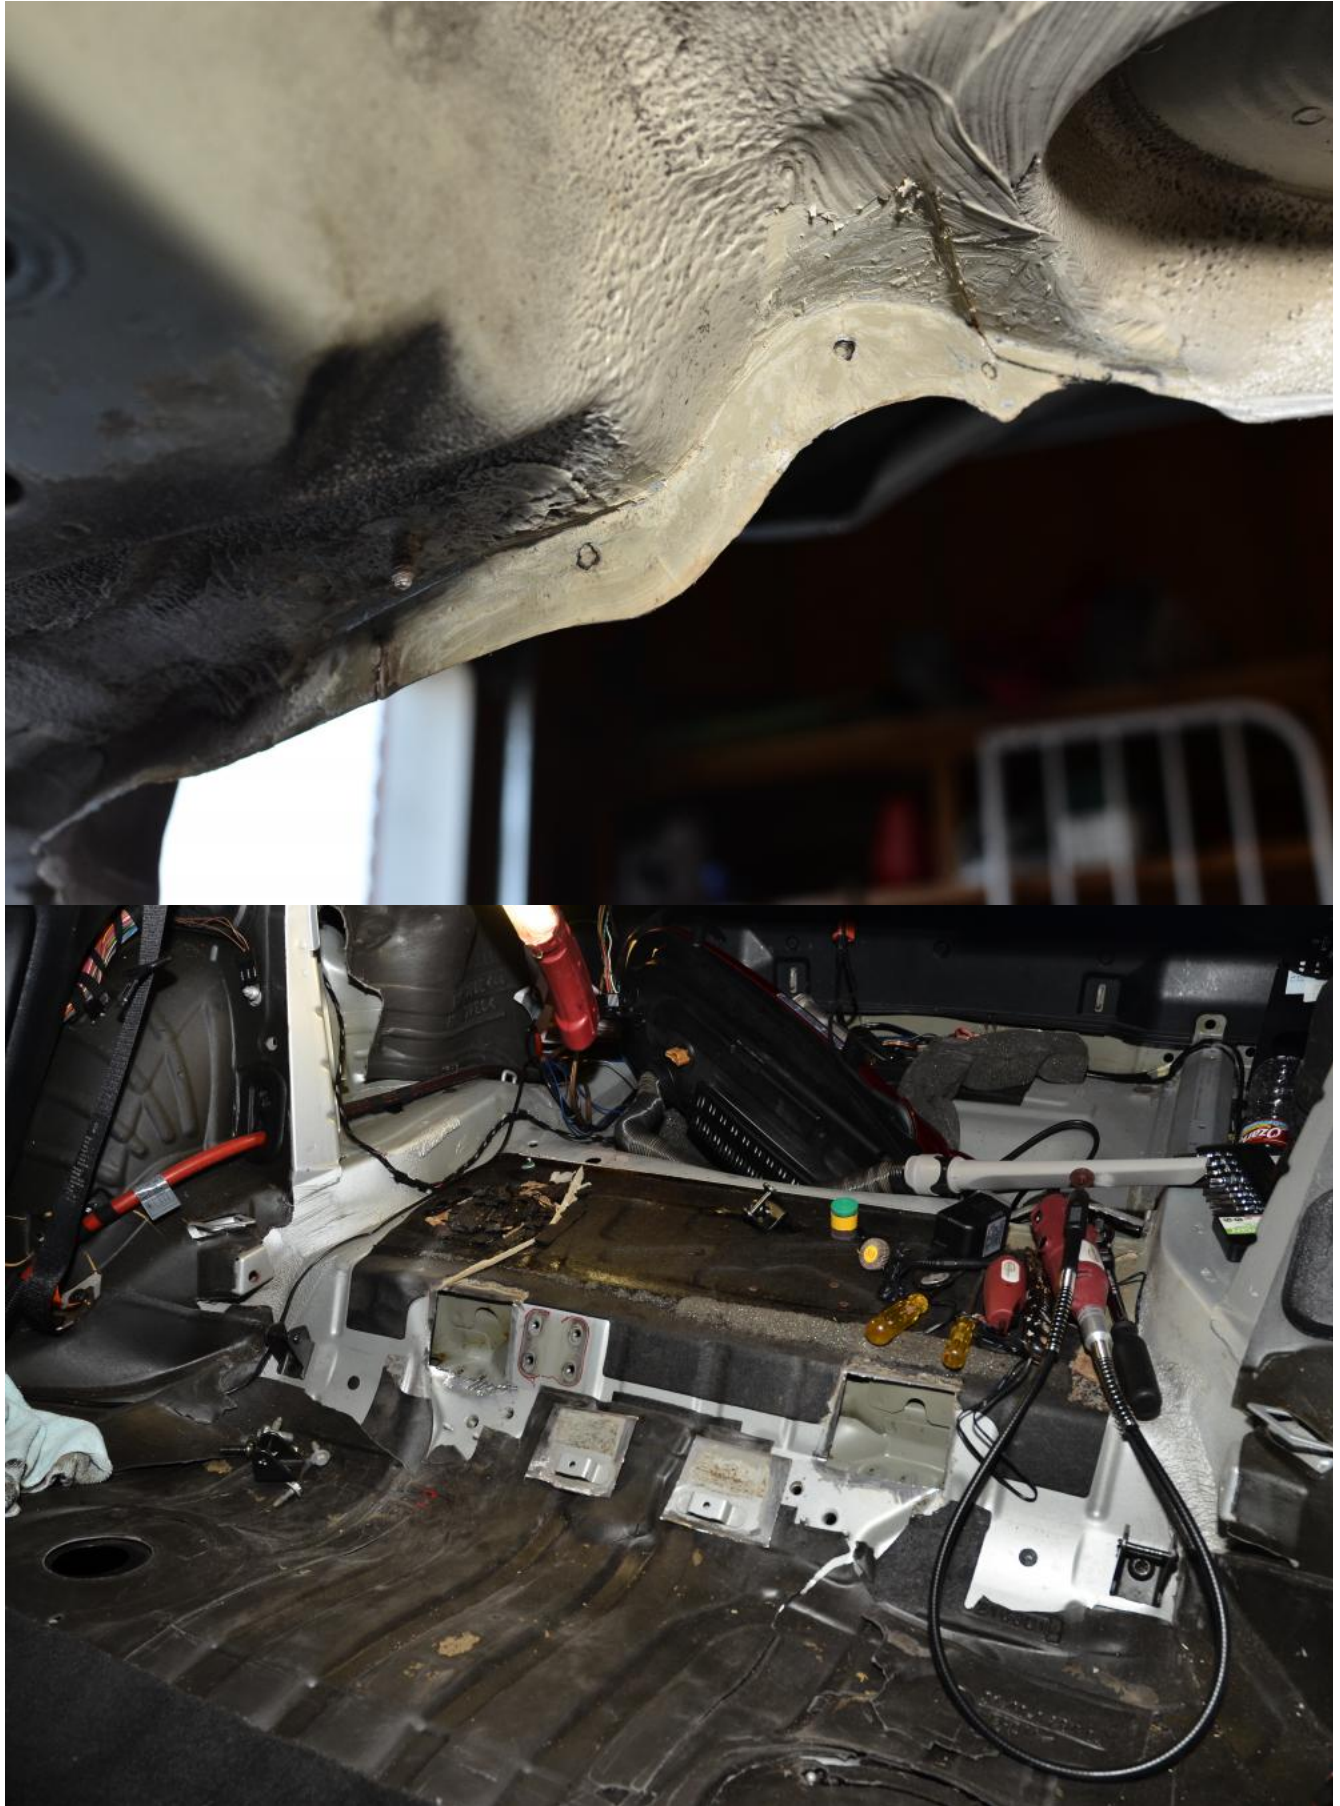
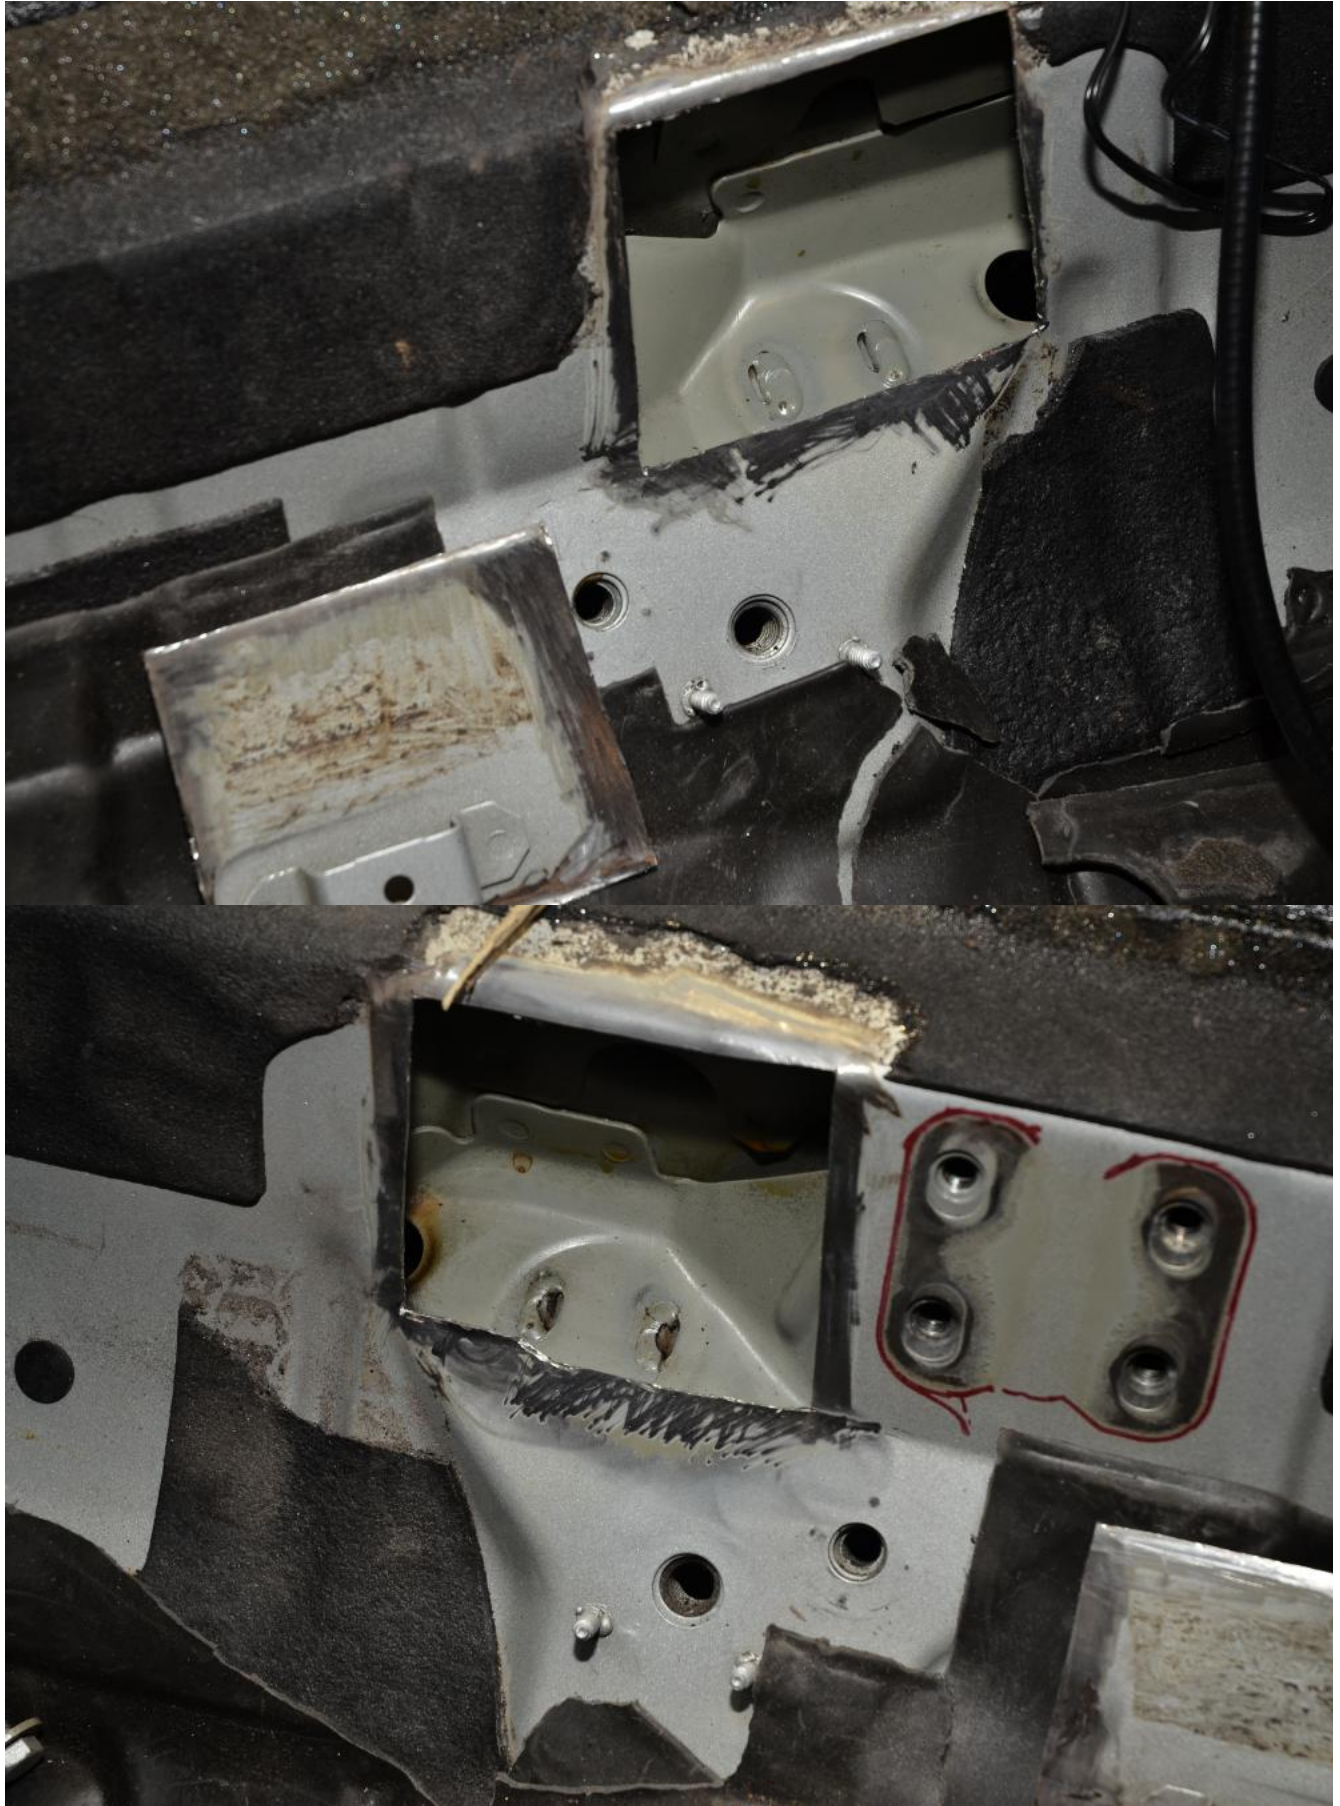
**\*Edit 1\*** A few pictures from the album:

**\*Edit 1\*** I ended up drilling the holes of the front mounts, enlarged them to 0.5" diameter, then installed an aircraft grade bolt (AN8) for each hole. For the rear driver mount, I didn't cut and weld the top like other suggested because in my opinion the top side will never fail for the M3 due to the extra factory vertical welds. I repaired the spot welds, added a line of weld for the bottom flange on the wheelwell, and add fasteners around the failed spot weld to provide additional strength. I bought the reinforcement plate but didn't weld them on because it won't help anything. I already change how the load transfer on the front mounts. The bottom panel will never fail with the top panel connected always by the bolt.

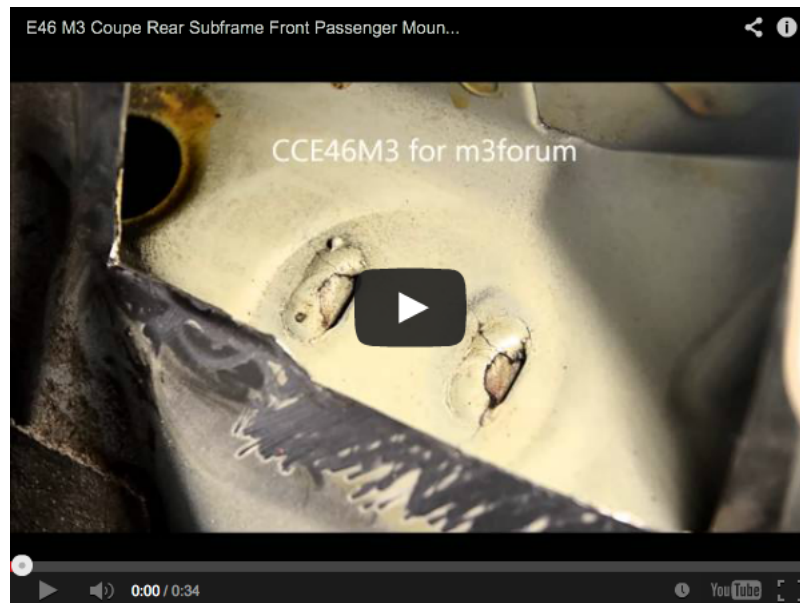
1.) how the top side of the front passenger mount looks like under hand-applied load on the stud when it was broken off from the top panel:

**For everyone doing the subframe repair, I highly recommend fixing the top side of the front mount if you have cracks on the bottom because they fail first.**

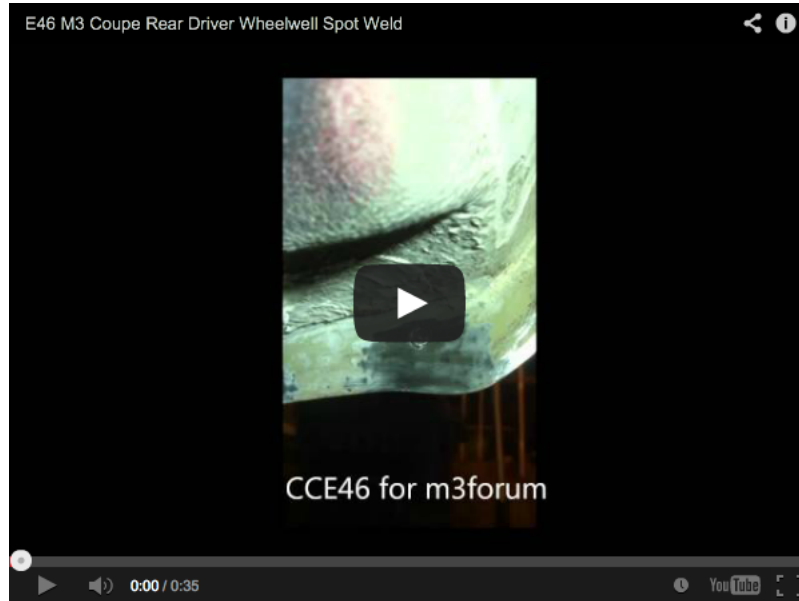
2.) with hand-applied force, how easily the bottom chassis panel near the rear driver mount was flexed without any spot weld holding on it (after spot welds were cracked)

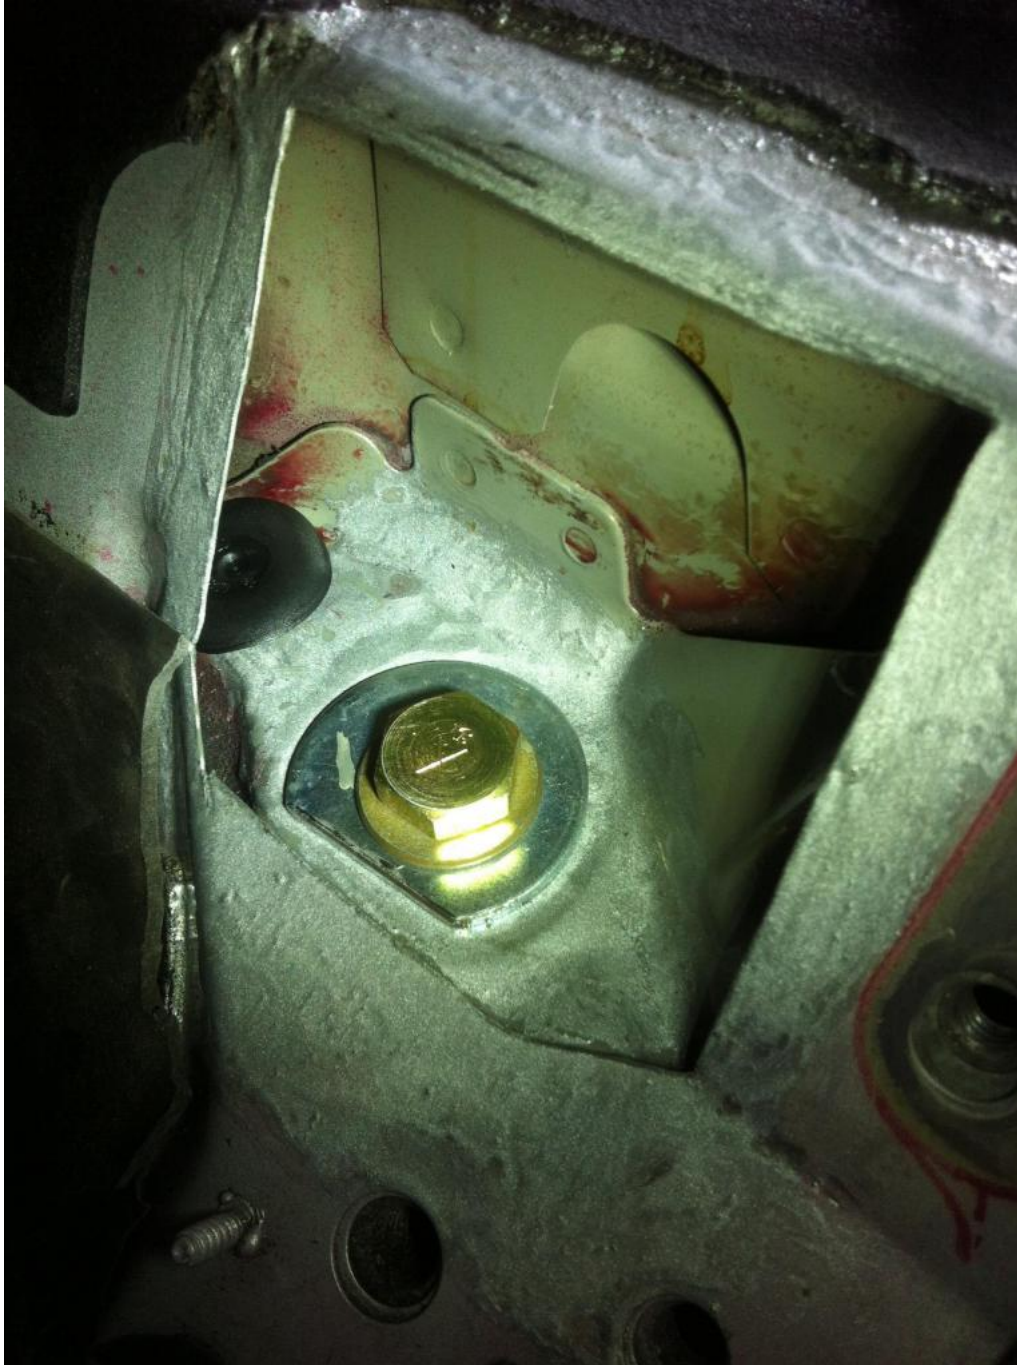
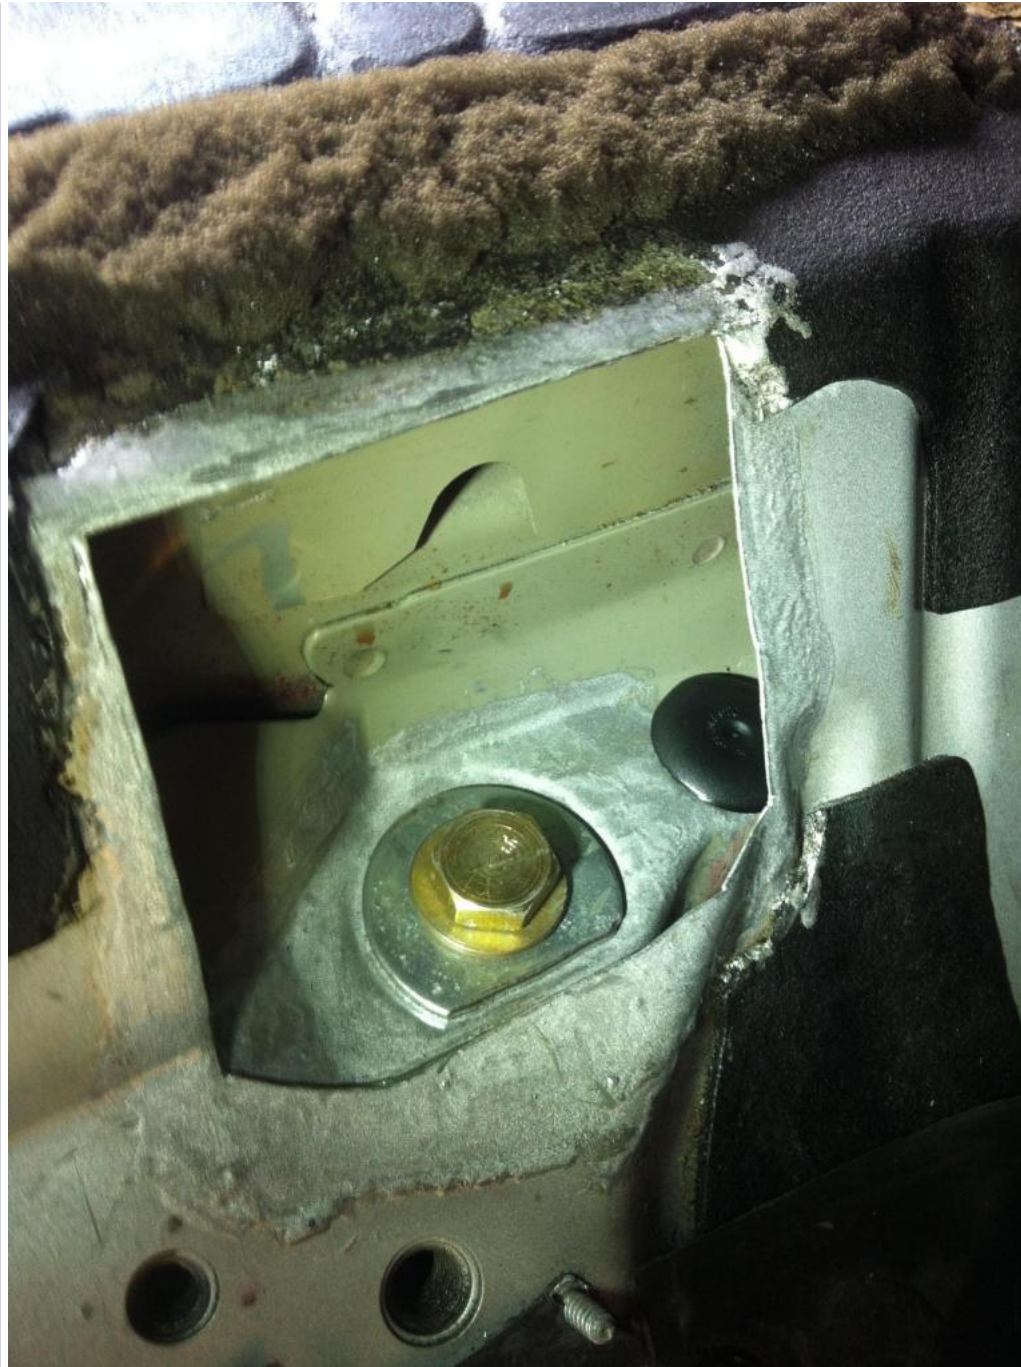
Can you point out where you've placed these two bolts??

I assume you are asking where I purchase the bolts from (since it's pretty obvious the bolts are used for the front mounts). I bought them online from [aircraftspruce.com](http://aircraftspruce.com).

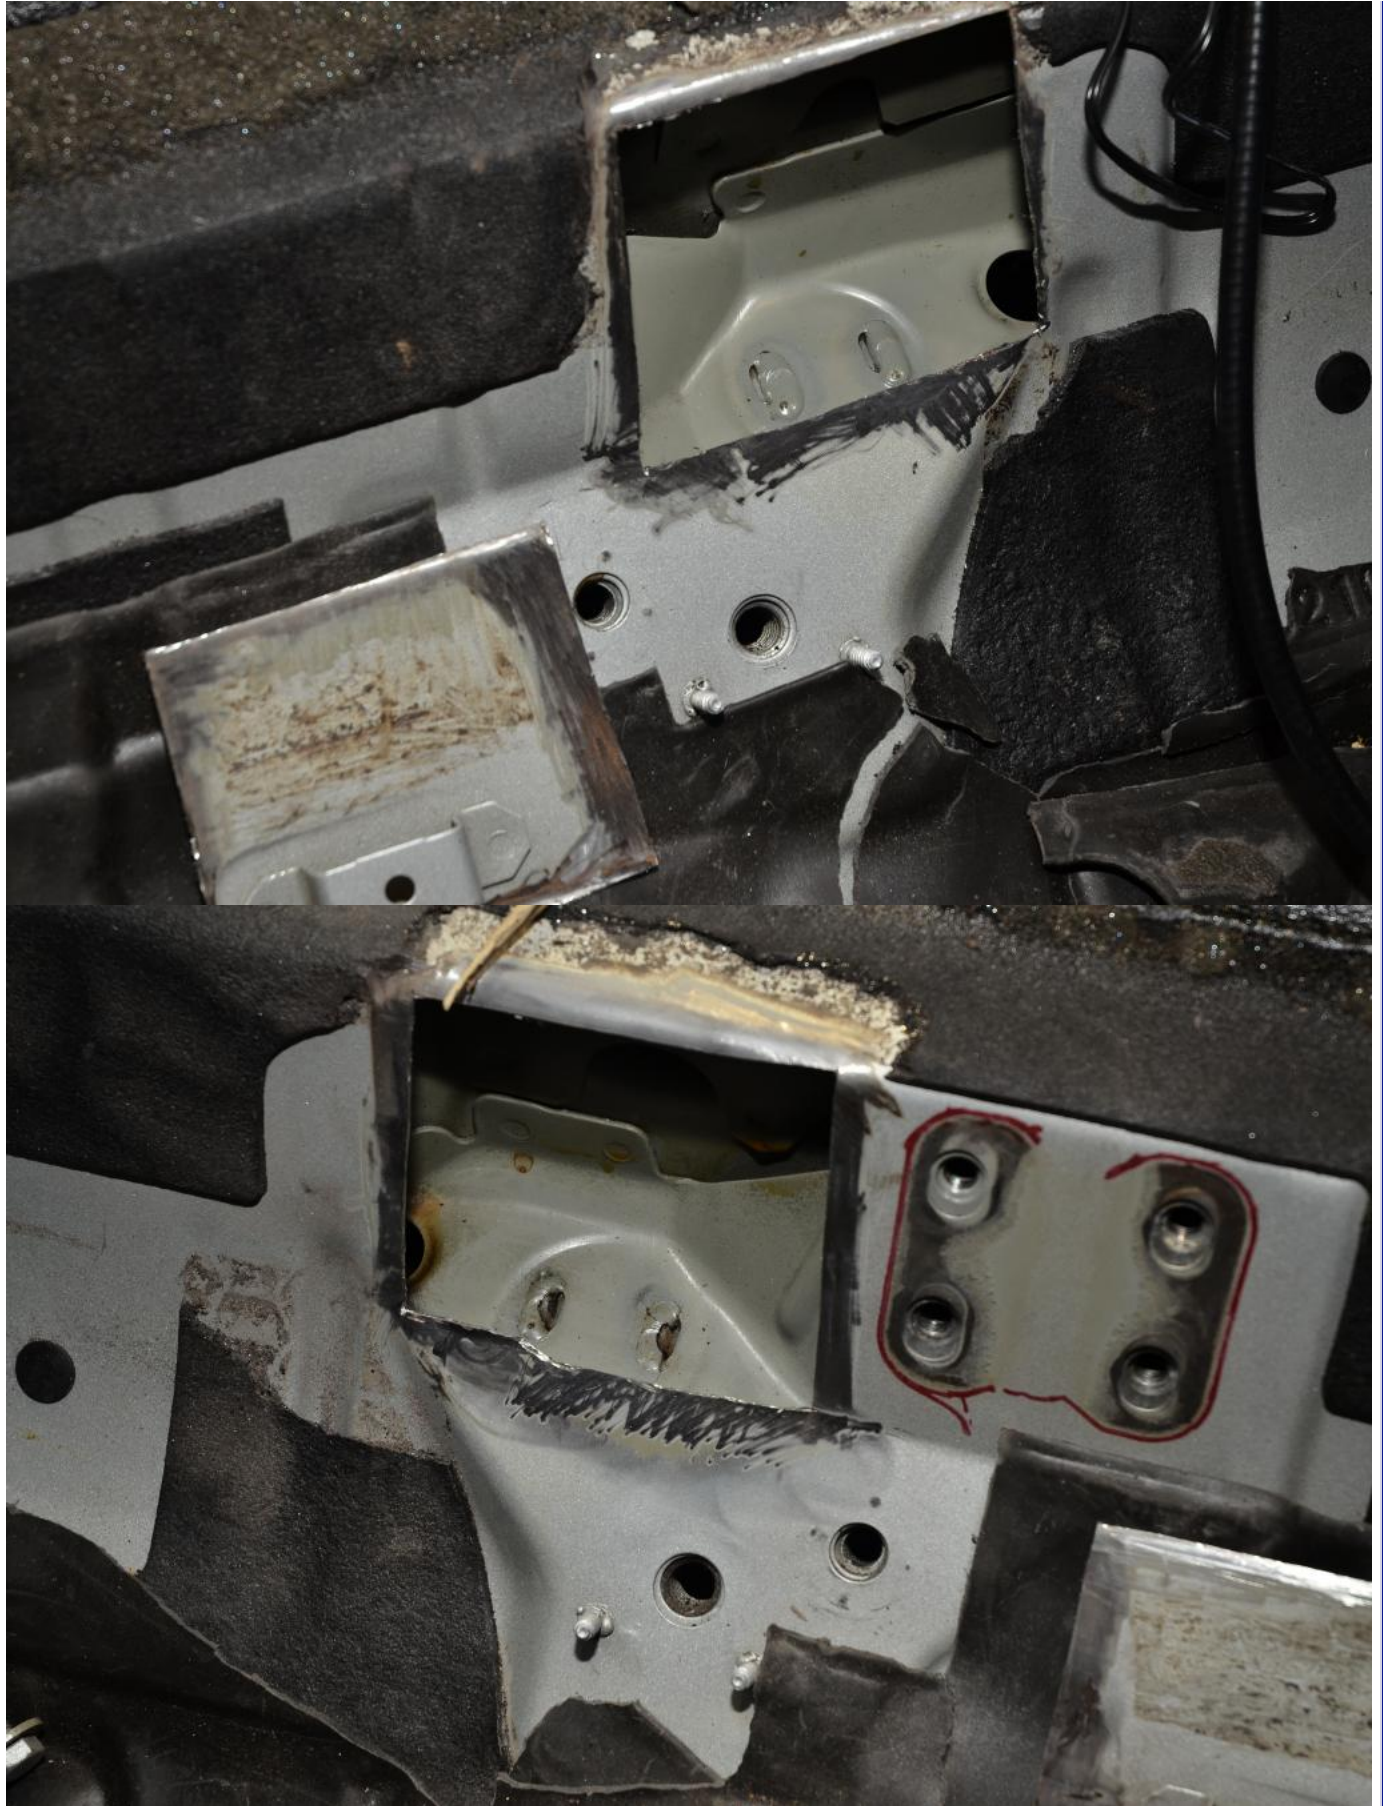
Are they directly over these weld fixes?? If so did you grind down the welds? Seems unlikely that you did!!

I did grind down the factory weld, then used dye penetrant to check for cracks, then drilled holes 1/16" at the end of the crack as "cracker stopper", then welded the crack, then grind down the weld bead flat to the surface, then drilled the front mount from the bottom hole, then step drilled the hole 1/64" at a time until the diameter reached 0.5", then paint the area with POR15 Silver for corrosion protection and providing surface strength (and fill out tiny holes), then installed the long AN8 bolt with washers from top down. That's the picture I took after all that work.

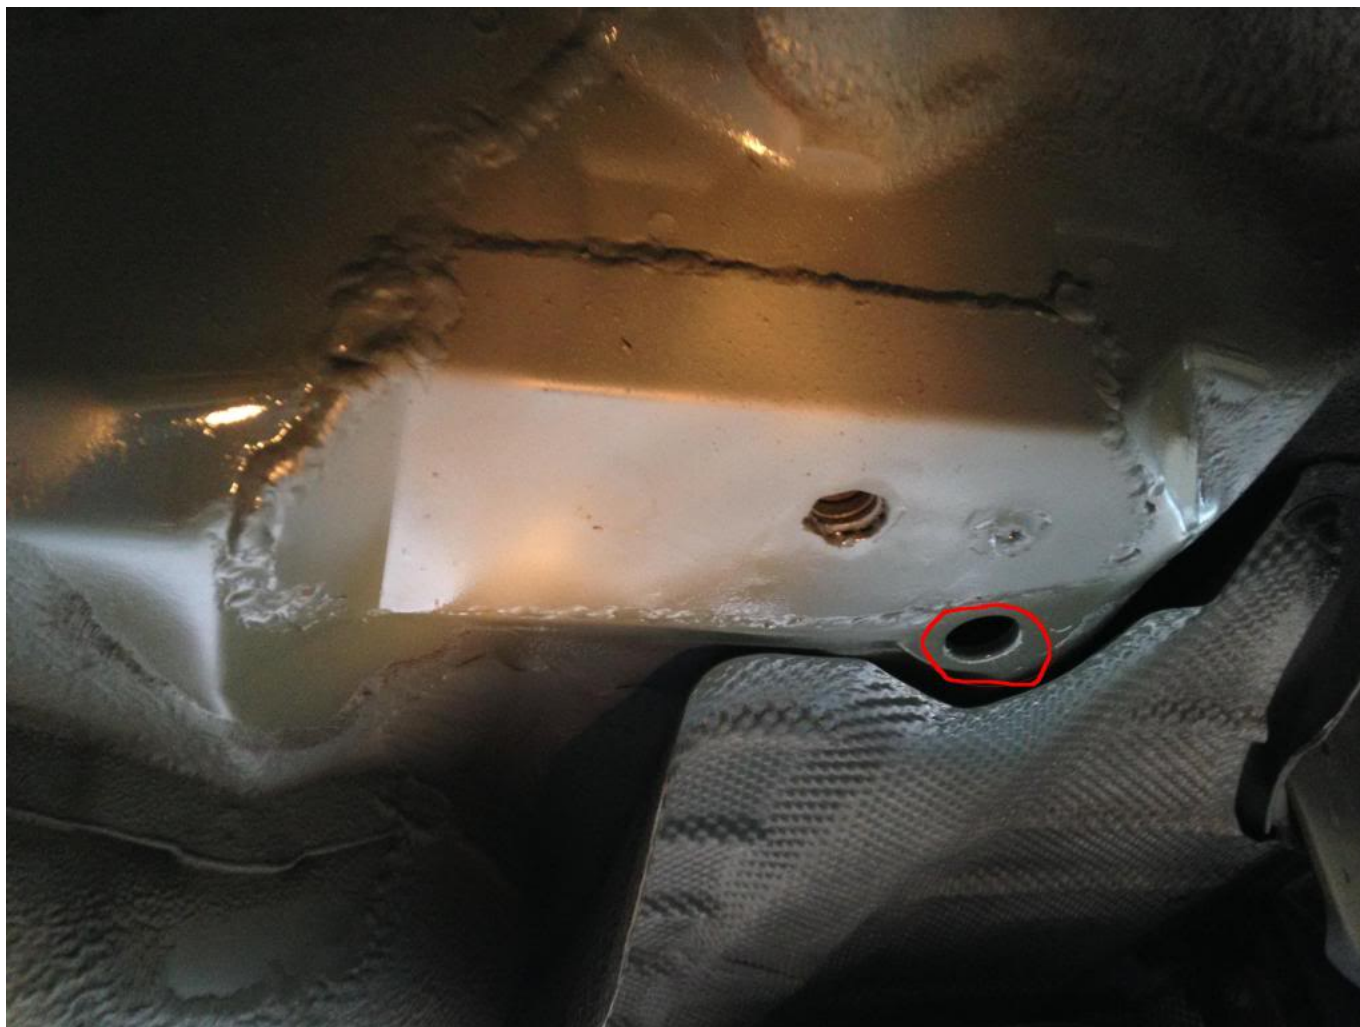
I'm looking for this one that covers this hole

The part number for that one is 07147140850 (D=20mm)

The one on the lower left hand.

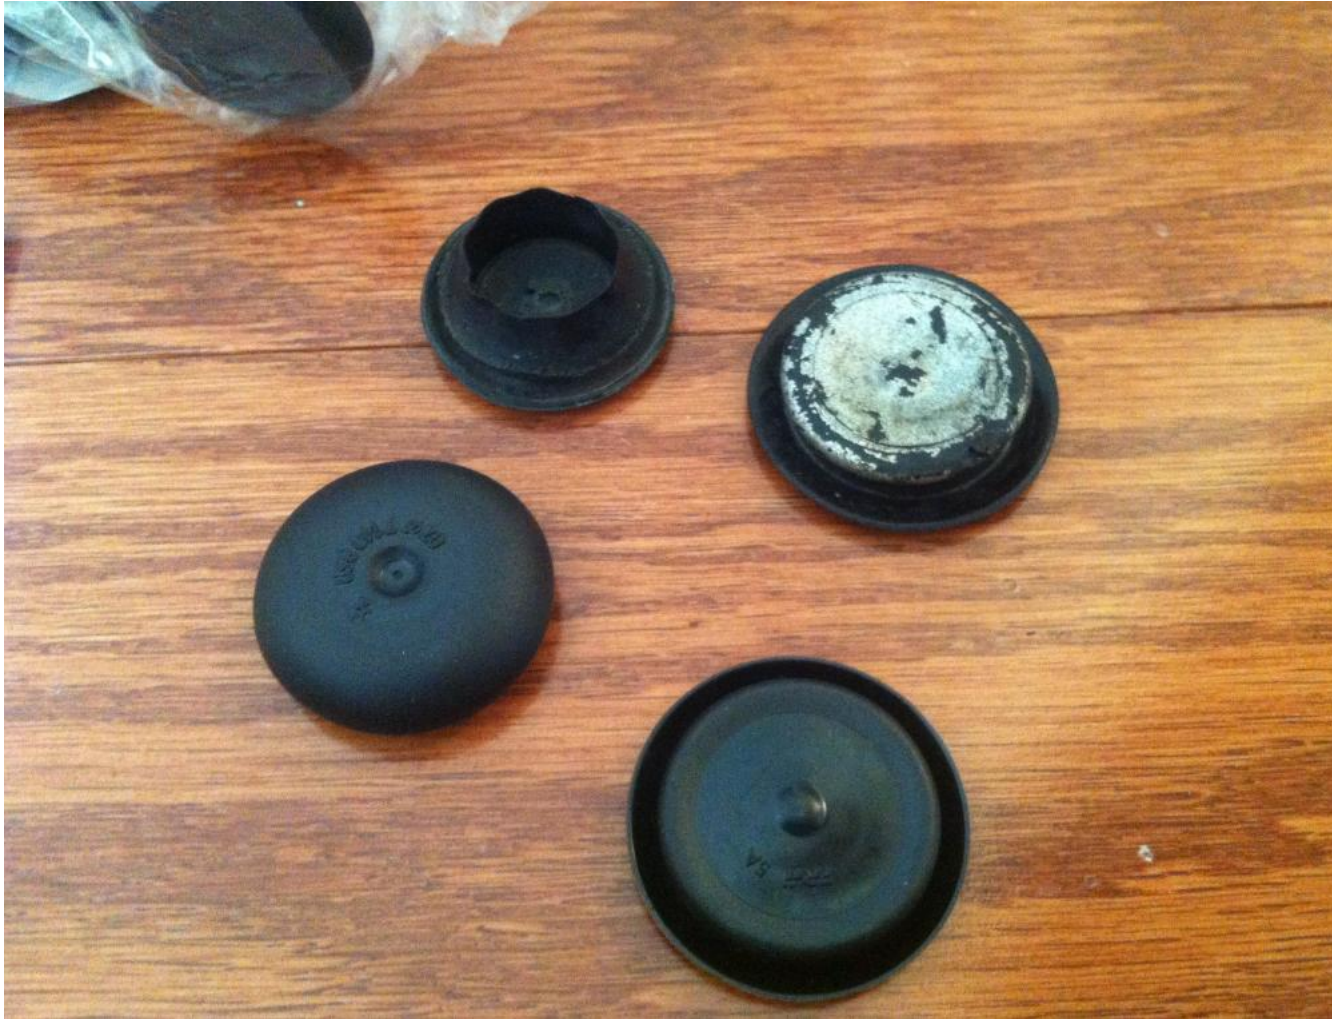
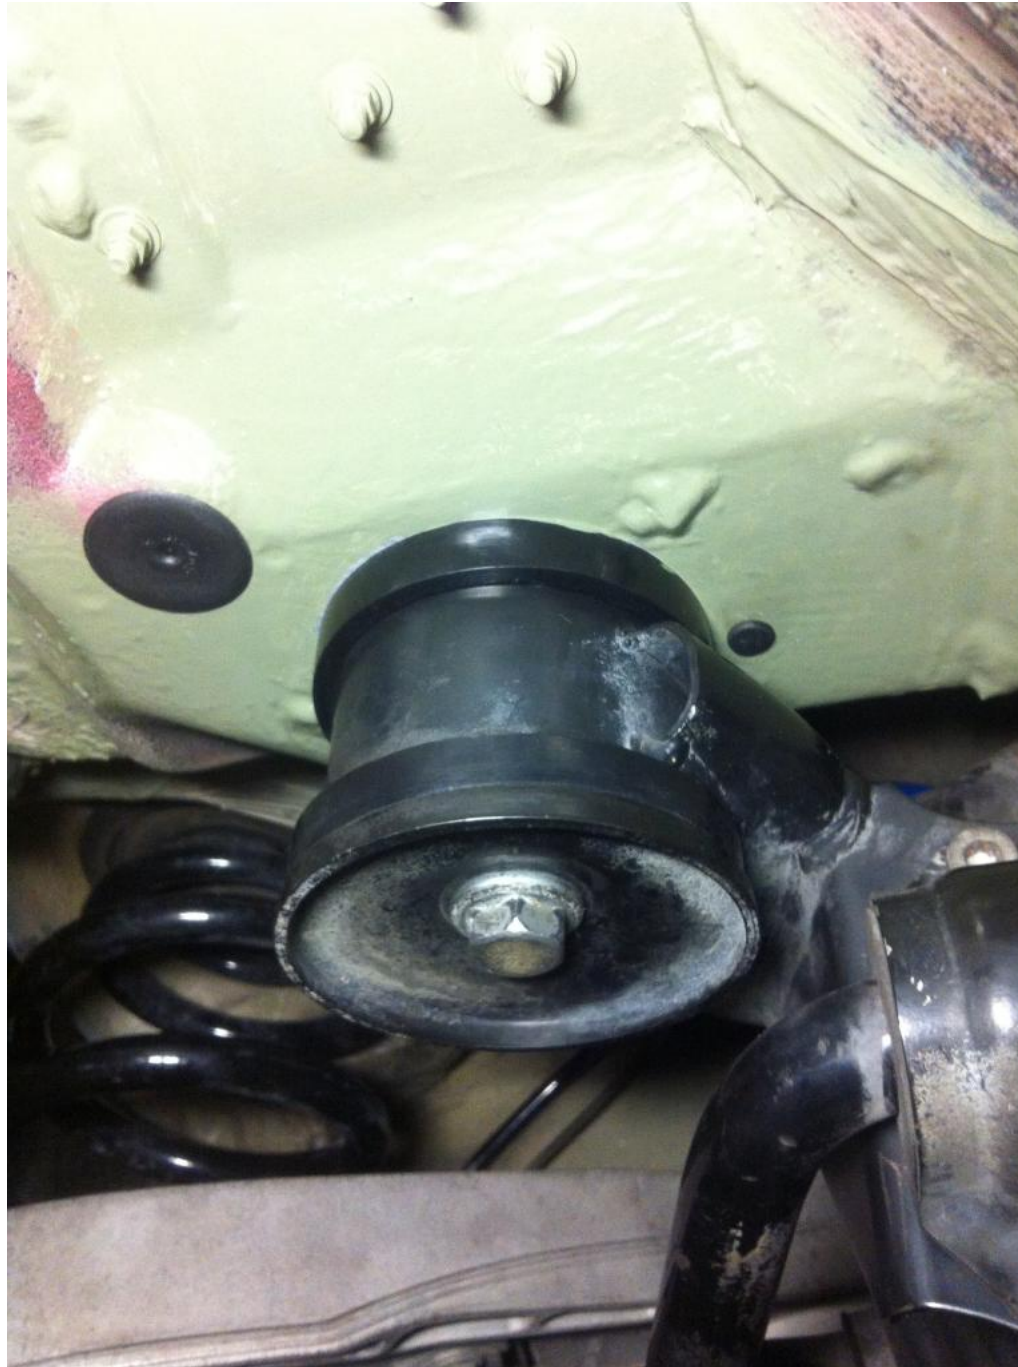
It looks a little different than the old, dried, and cracked ones on my car but they fit tightly in the hole. That's all I cared.

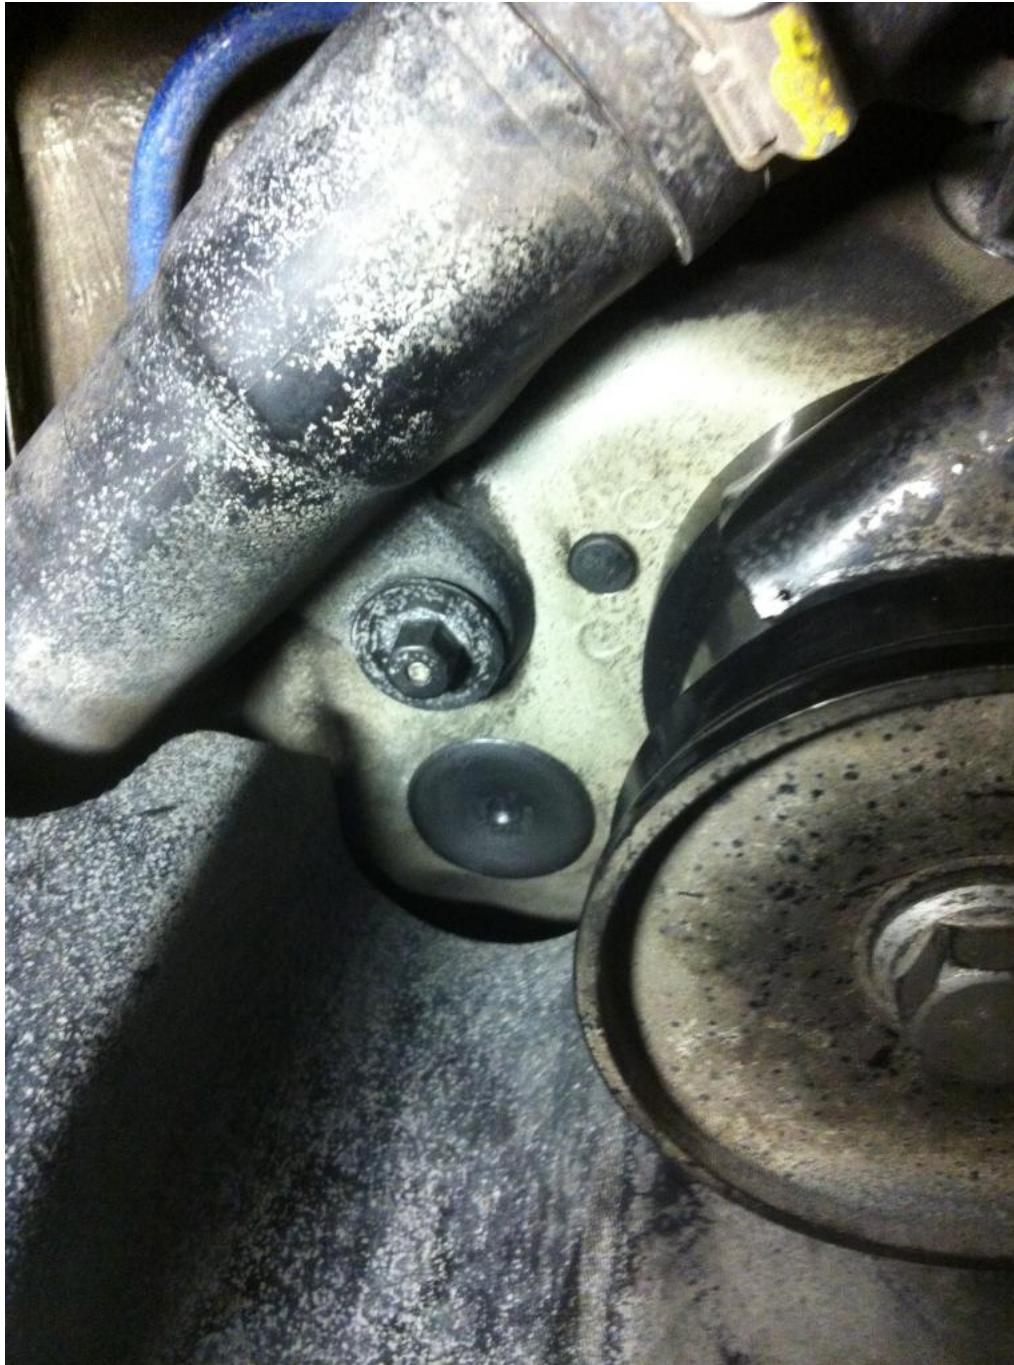
On the other side
